HOME INSPECTION REPORT

123 Anywhere Drive
St. John's, NL A1C 3Z9

Sample Document

DECEMBER 22, 2023

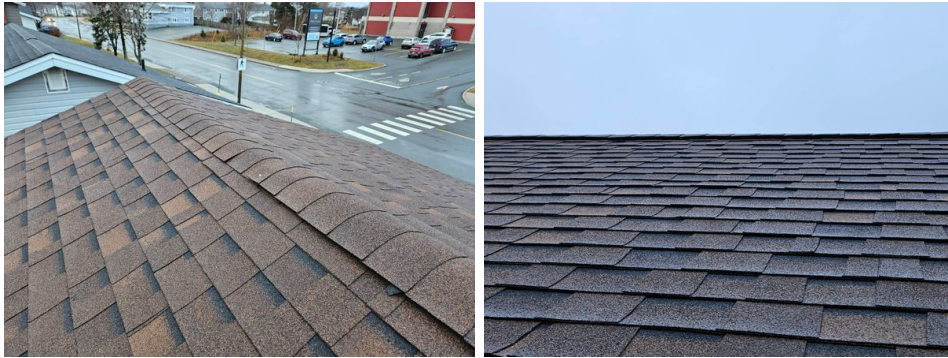
Slight. This is a common observation. Recommend monitoring for future condition. Client may choose to consult a qualified roofer for further information.

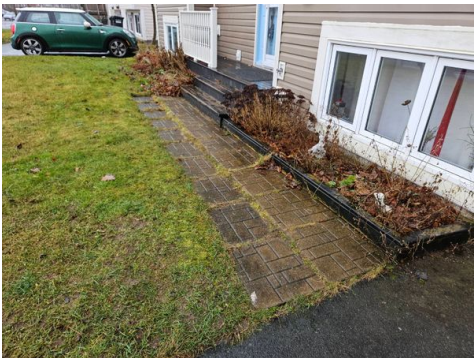
WORN

Worn or Uneven. Noted for safety. Client may choose to consult qualified personnel for further information.

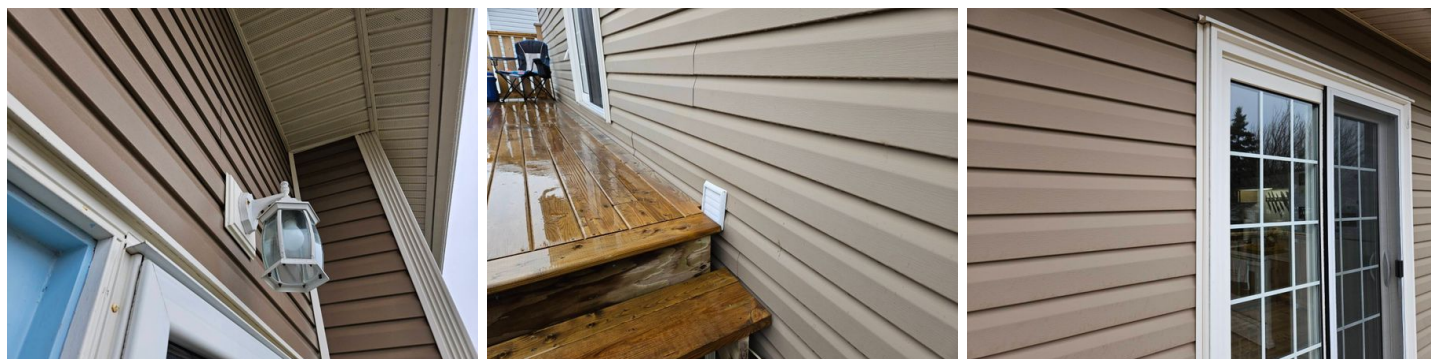
Worn, voids, or not present. Suggest caulking exterior locations as applicable per examples to aid in prevention of moisture entry.

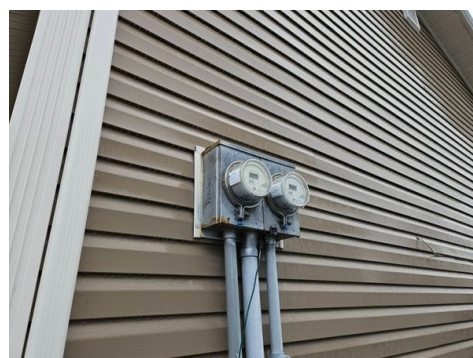
4.3.2 Cladding Installation

NOT CONTINUOUS BEHIND ELECTRICAL SERVICE

It's preferred that siding is continuous behind the electrical installation. Recommend monitoring for future condition. Consult qualified personnel if required.

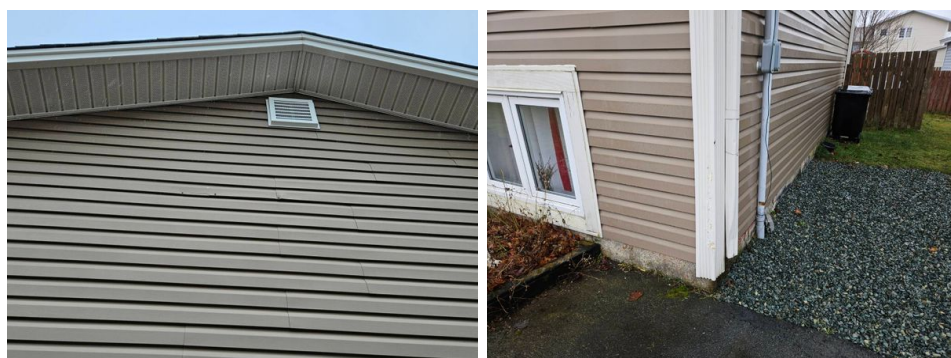
4.4.1 Exterior Cladding

MINOR ITEMS OR DAMAGE

Typical minor cladding items or damage observed. Noted per example(s) for informative reasons.

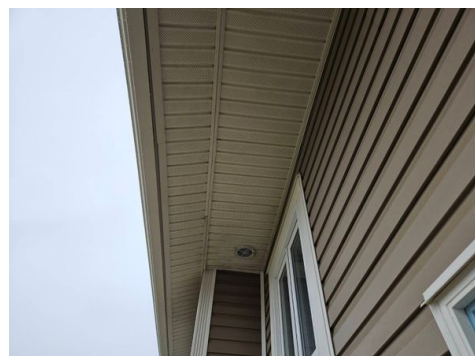
ORGANIC GROWTH

Discolouration or possible mildew observed. Suggest cleaning or improvement as required.

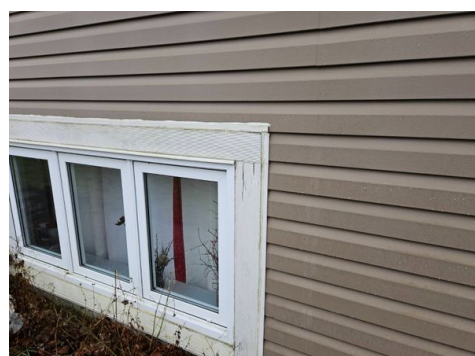
DETERIORATION

Recommend correction as required by qualified personnel. Note: Concealed deterioration may be present.

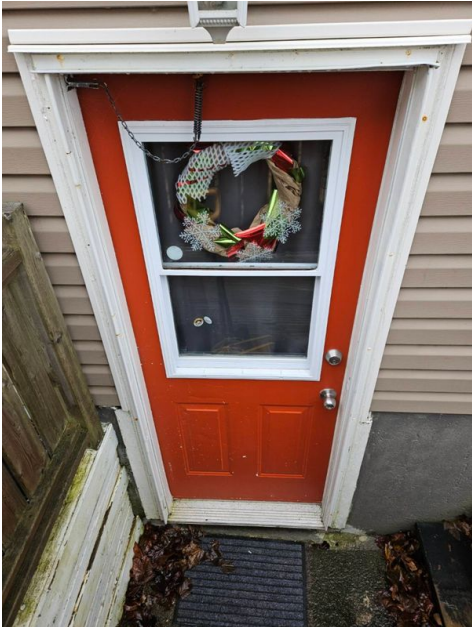
Surround trim and brick mold deteriorated. Recommend correction as required by qualified personnel to extend life of the door and aid in prevention of moisture entry.

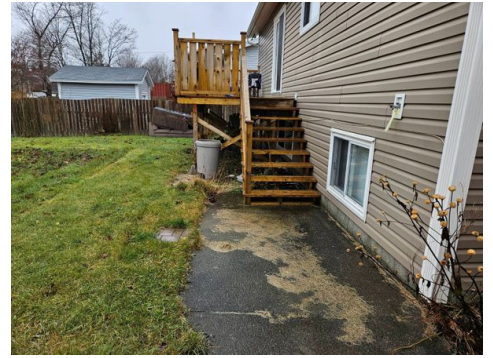
EXTERIOR GRADE

Slopes towards the home. This is a common observation. May increase susceptibility to wear or moisture related issues in some circumstances. Client may choose to consult qualified personnel for further information or evaluation.

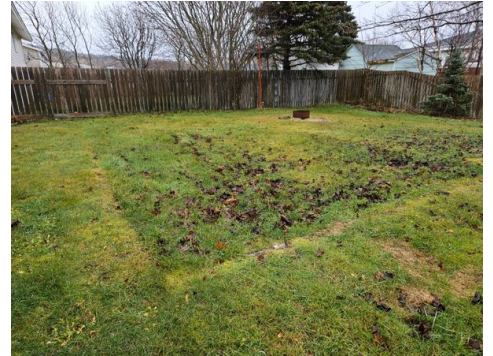
PREVIOUSLY DISTURBED

Surface non linear or previously disturbed. Recommend requesting disclosure to purpose from the vendor. Consult qualified personnel for further evaluation as required.

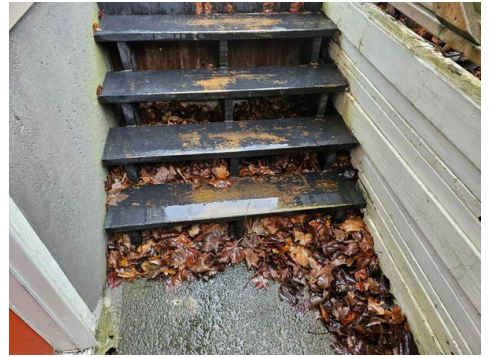
DEBRIS

Drainage obstructed by debris. Recommend correction to prevent flooding.

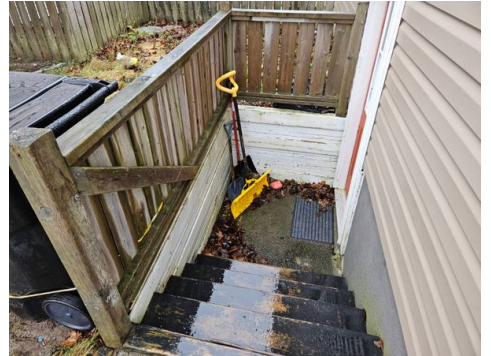
RAIL(S)

Not present or ineffective. Recommend correction as required by qualified personnel due safety.

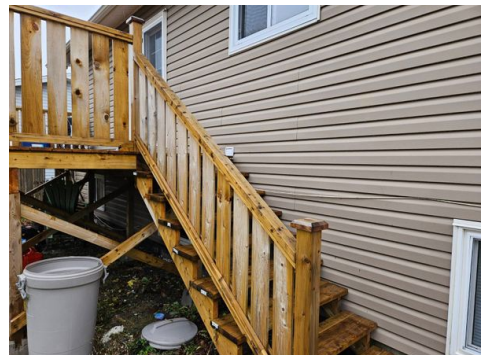
HAND HOLD- GRASPABLE

Rail(s) do not provide a well graspable hand hold (common). Noted for safety. Client may choose to consult qualified personnel for further information.

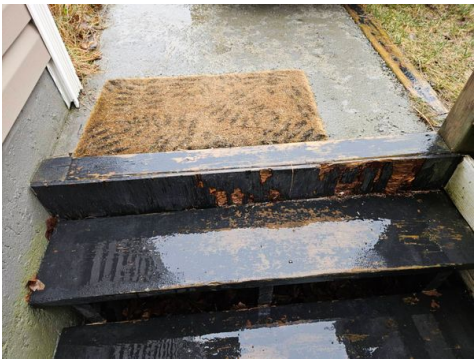
WEAR

Wear or deterioration. Recommend correction as required by qualified personnel due safety.

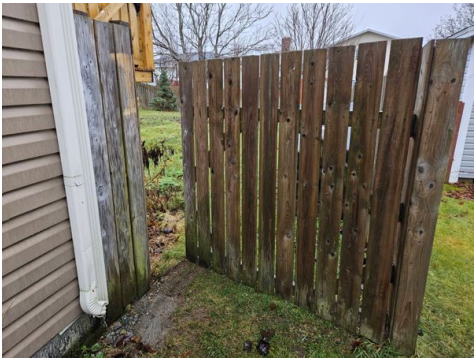
GATES

Contact or difficult to operate. Recommend correction as required by qualified personnel.

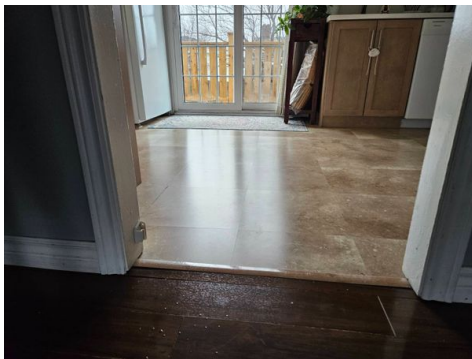
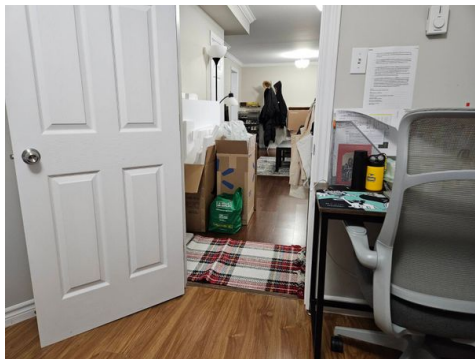
FRAMING METHODS

Framing is not constructed per modern practices. Floors or framing appear not plumb or level at some areas. This is a common occurrence. Bridging, blocking, or strapping is not present between floor joists. Non typical framing or support methods at the subfloor above the crawlspace (a knee wall would typically be provided by modern practice). Noted per example(s). Recommend monitoring for future condition. Client may choose to consult qualified personnel for further information.

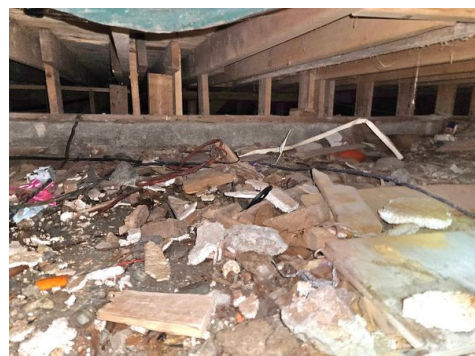
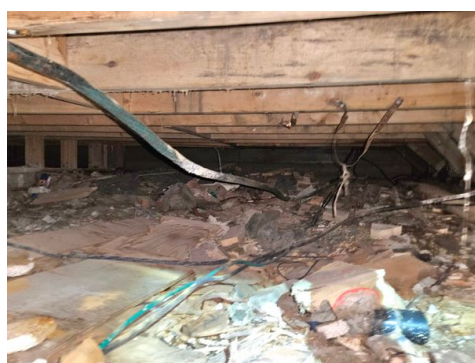
5.1.2 Observations

CRAWLSPACE VENTILATION

Evidence of elevated humidity at the crawlspace. Prior repairs visible at framing. Ventilation not observed. Recommend further evaluation by appropriately qualified personnel and correction as required to minimize humidity and to prevent future deterioration.

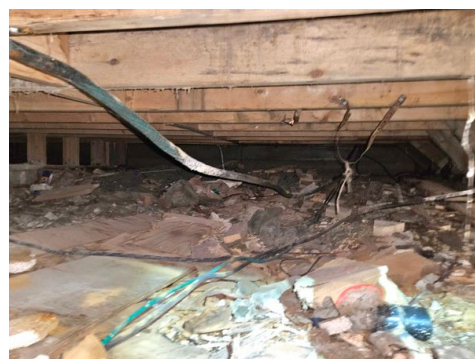
5.1.3 Observations

EARTH FLOOR EXPOSED

Vapour barrier is not present (common due age of the home). Recommend provision to provide separation from the earth and to minimize humidity.

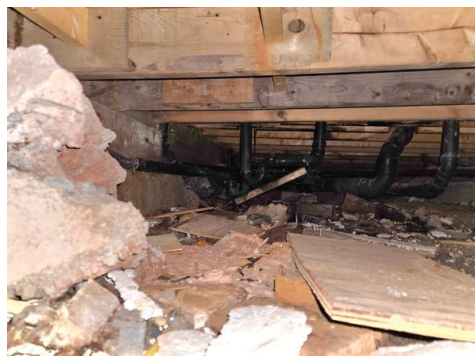
5.1.4 Observations

DEBRIS

Noted per examples. Recommend removal by qualified personnel to facilitate safe access.

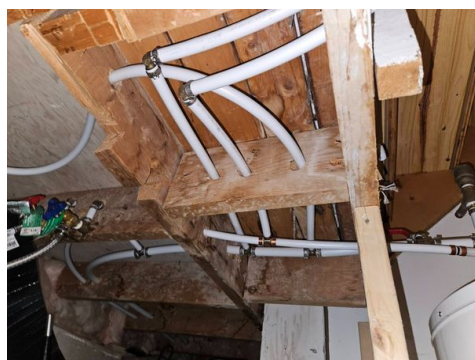
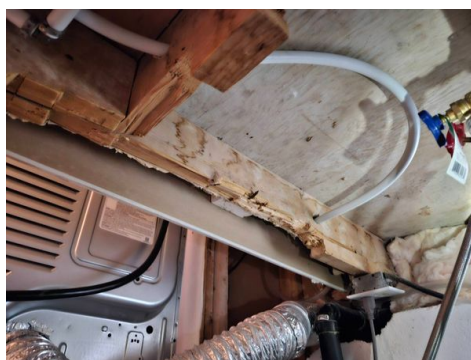
This is a common observation. Joists notched or altered. Recommend monitoring for future condition. Consult qualified personnel if required.

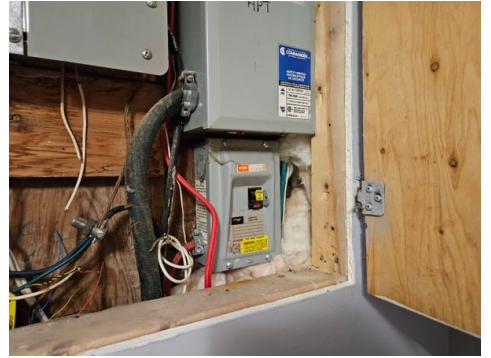
Breaker turned off. Purpose is not apparent. Recommend requesting disclosure from the vendor. Consult a licenced electrician as required. Note: Possibly utilized by a prior swimming pool installation.

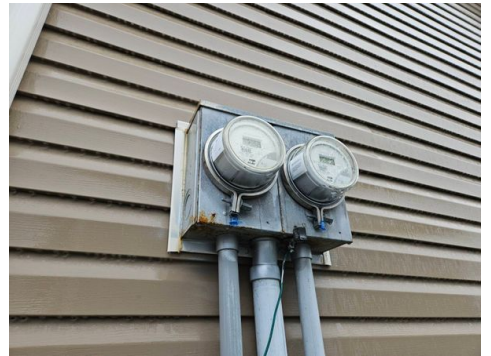
RUST PRESENT

Rust observed. Recommend monitoring for future condition. Consult a licenced electrician if required.

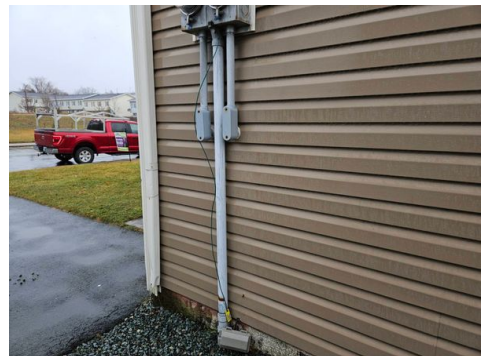
CLAMPS

Not present. Recommend provision as required by qualified personnel.

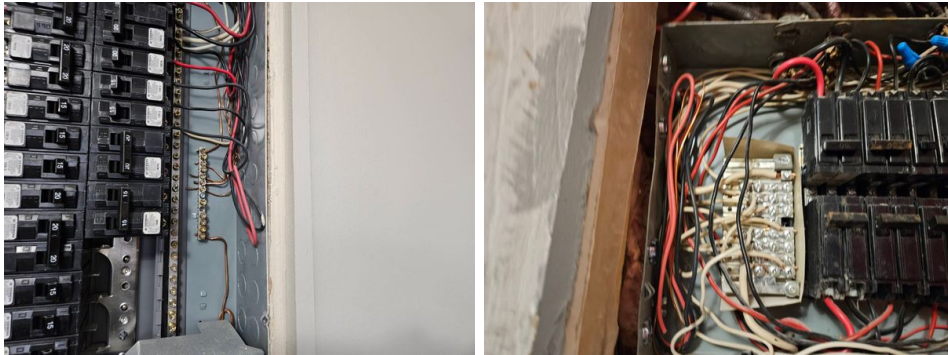
ABANDONED WIRING

Unused wiring is not well terminated. Recommend correction by a licenced electrician due fire safety.

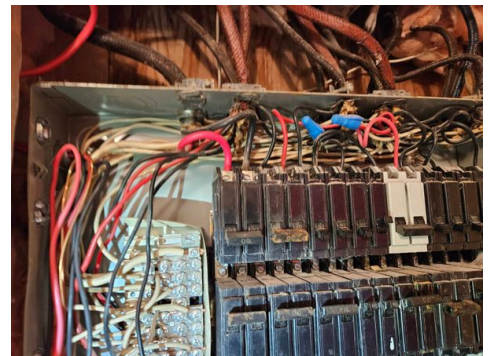
BREAKER SIZE

Oven circuit appears protected by protected by 60 amp breakers. 40 amp breakers are typically observed. Recommend further evaluation of suitability by a licenced electrician due fire safety.

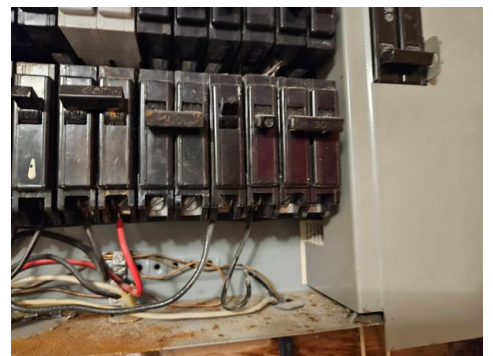
OVERSIZE BREAKER

14 gauge wiring is protected by 20 amp breaker(s). Recommend correction as required by a licenced electrician due fire safety. Note: The circuit appears not presently in use.

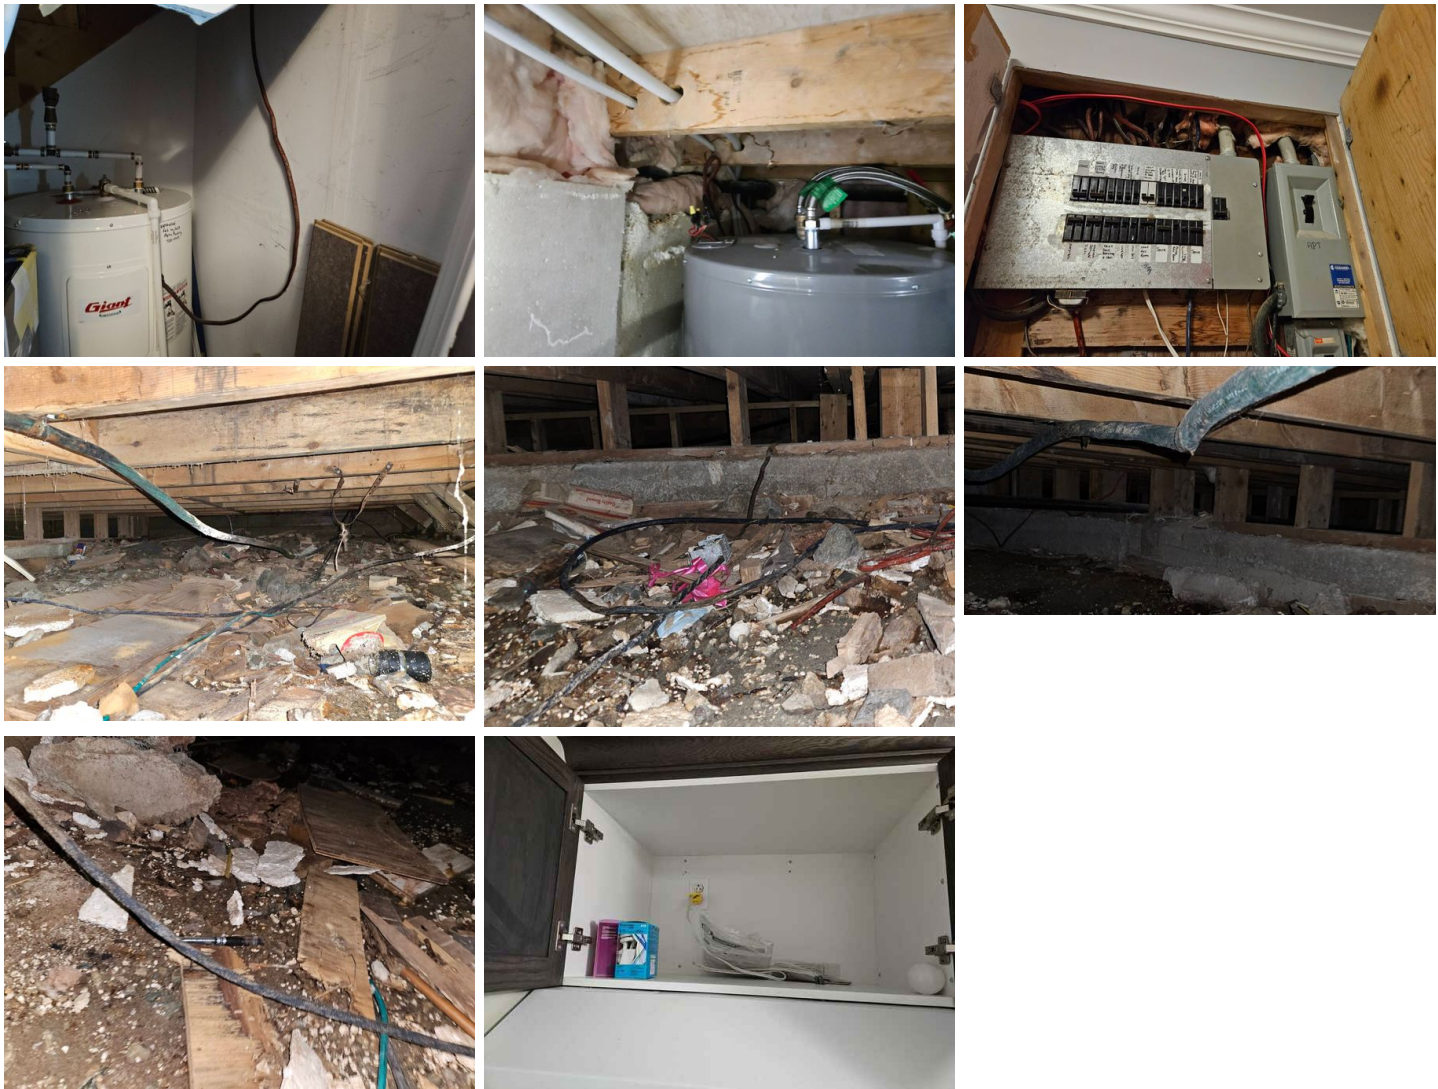
Not well secured. Exposed or improper connections. Covers not present. Insulation damaged. Noted per examples. Recommend further evaluation and correction as required by a licenced electrician due fire safety.

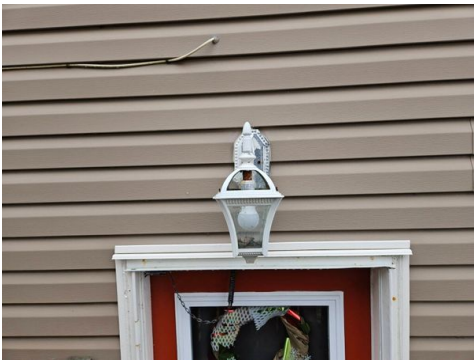
6.13.1 Outdoor Lighting
RUSTED OR DAMAGED

Fixture(s) rusted or damaged. Recommend replacement by qualified personnel.

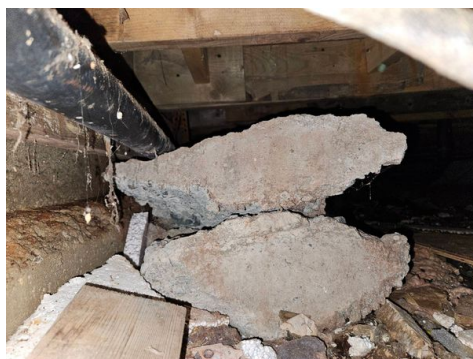
Moisture visible at waste plumbing beneath the basement bathroom. Not well supported. Recommend correction as required by a licenced plumber to due sanitary reasons.

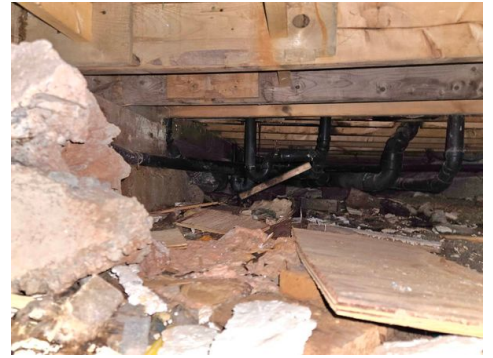
Waste plumbing and venting is not configured to modern standards. This is a common occurrence due to the age of the home. Fixtures appear located further than recommended from venting. Recommend monitoring for proper function. Client may choose to consult a licenced plumber for further information.

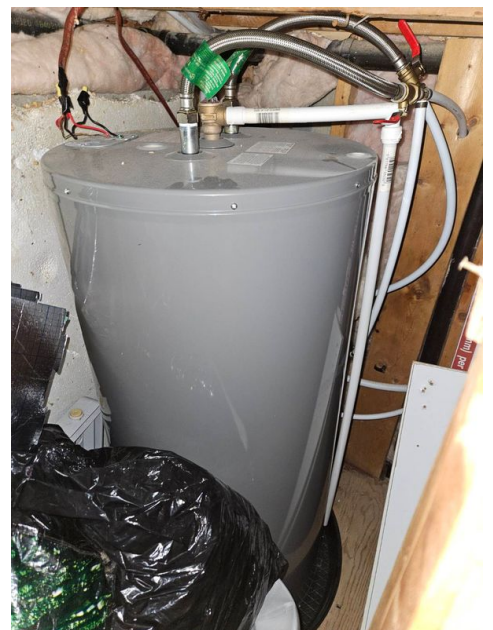
The data plate is not present. Unable to verify the age of the tank. Recommend requesting disclosure from the vendor. Consult a licenced plumber for further evaluation as required.

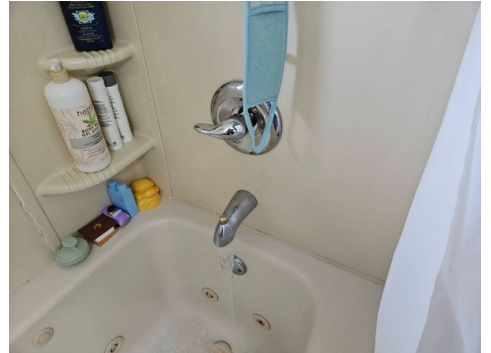
Recommend correction as required by a licenced plumber to prevent water damage.

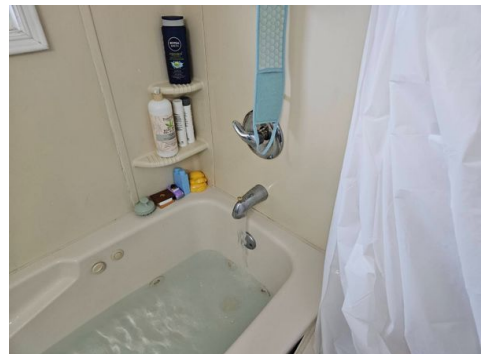
Fixture is slightly noisy during operation. Noted for informative reasons. Client may choose to consult a licenced plumber for further information.

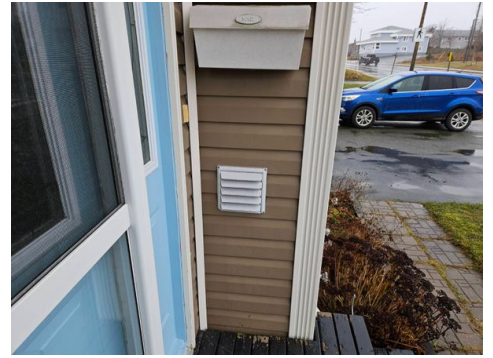
After market weather hoods are available to install over HRV inlet vent(s). Consider provision to minimize the potential for snow or moisture ingestion.

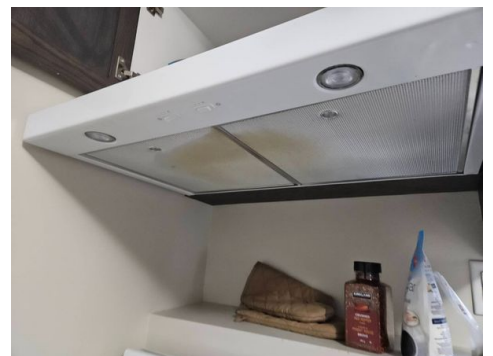
Not clean. Recommend cleaning or replacement as required.

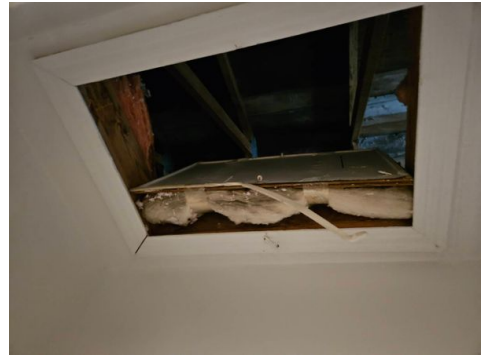
Attic hatch dimensions are less than modern practice. Noted for client courtesy. Consider enlargement by qualified personnel.

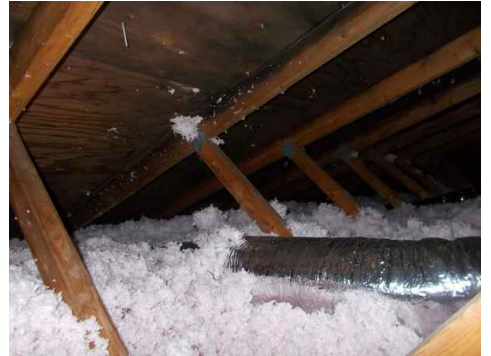
Attic soffit ventilation appears less than recommended by modern practice (common due age of the home). Recommend correction or upgrade as recommended by qualified personnel to ensure adequate airflow.

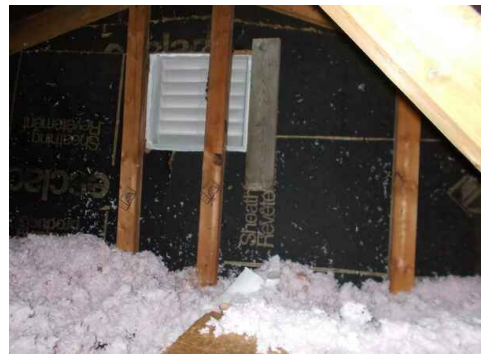
Gable ventilation is commonly not present when ridge venting is installed (appears redundant). Recommend enclosing to aid in prevention of moisture entry during periods of high wind. Client may choose to consult a qualified roofer for further information.

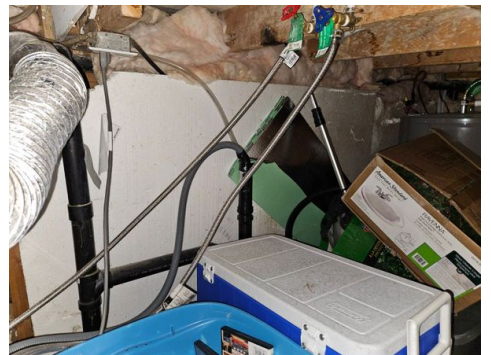
Exposed Styrofoam insulation observed (area unfinished). Noted due fire safety. Client may choose to consult qualified personnel for further information.

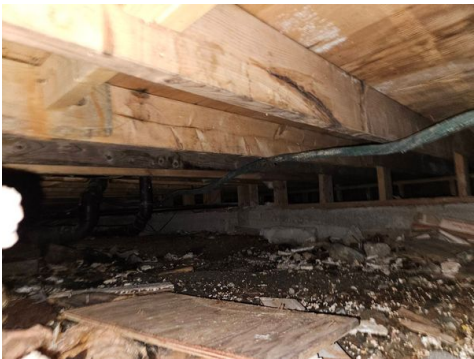
The floor above the crawlspace is not insulated. Noted due efficiency. Client may choose to consult qualified personnel for further information.

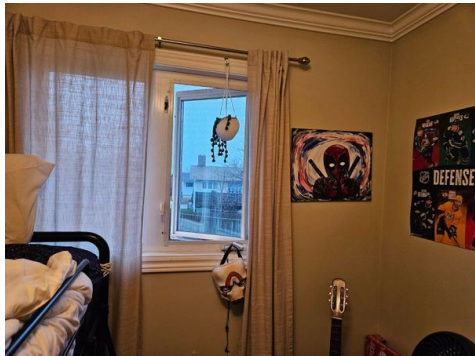
Bedroom window opening dimensions are less than the modern egress requirements. Noted for safety. Client may choose to consult qualified personnel for further information.

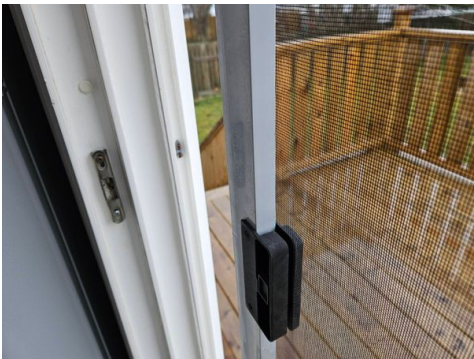
Recommend repair or replacement as required.

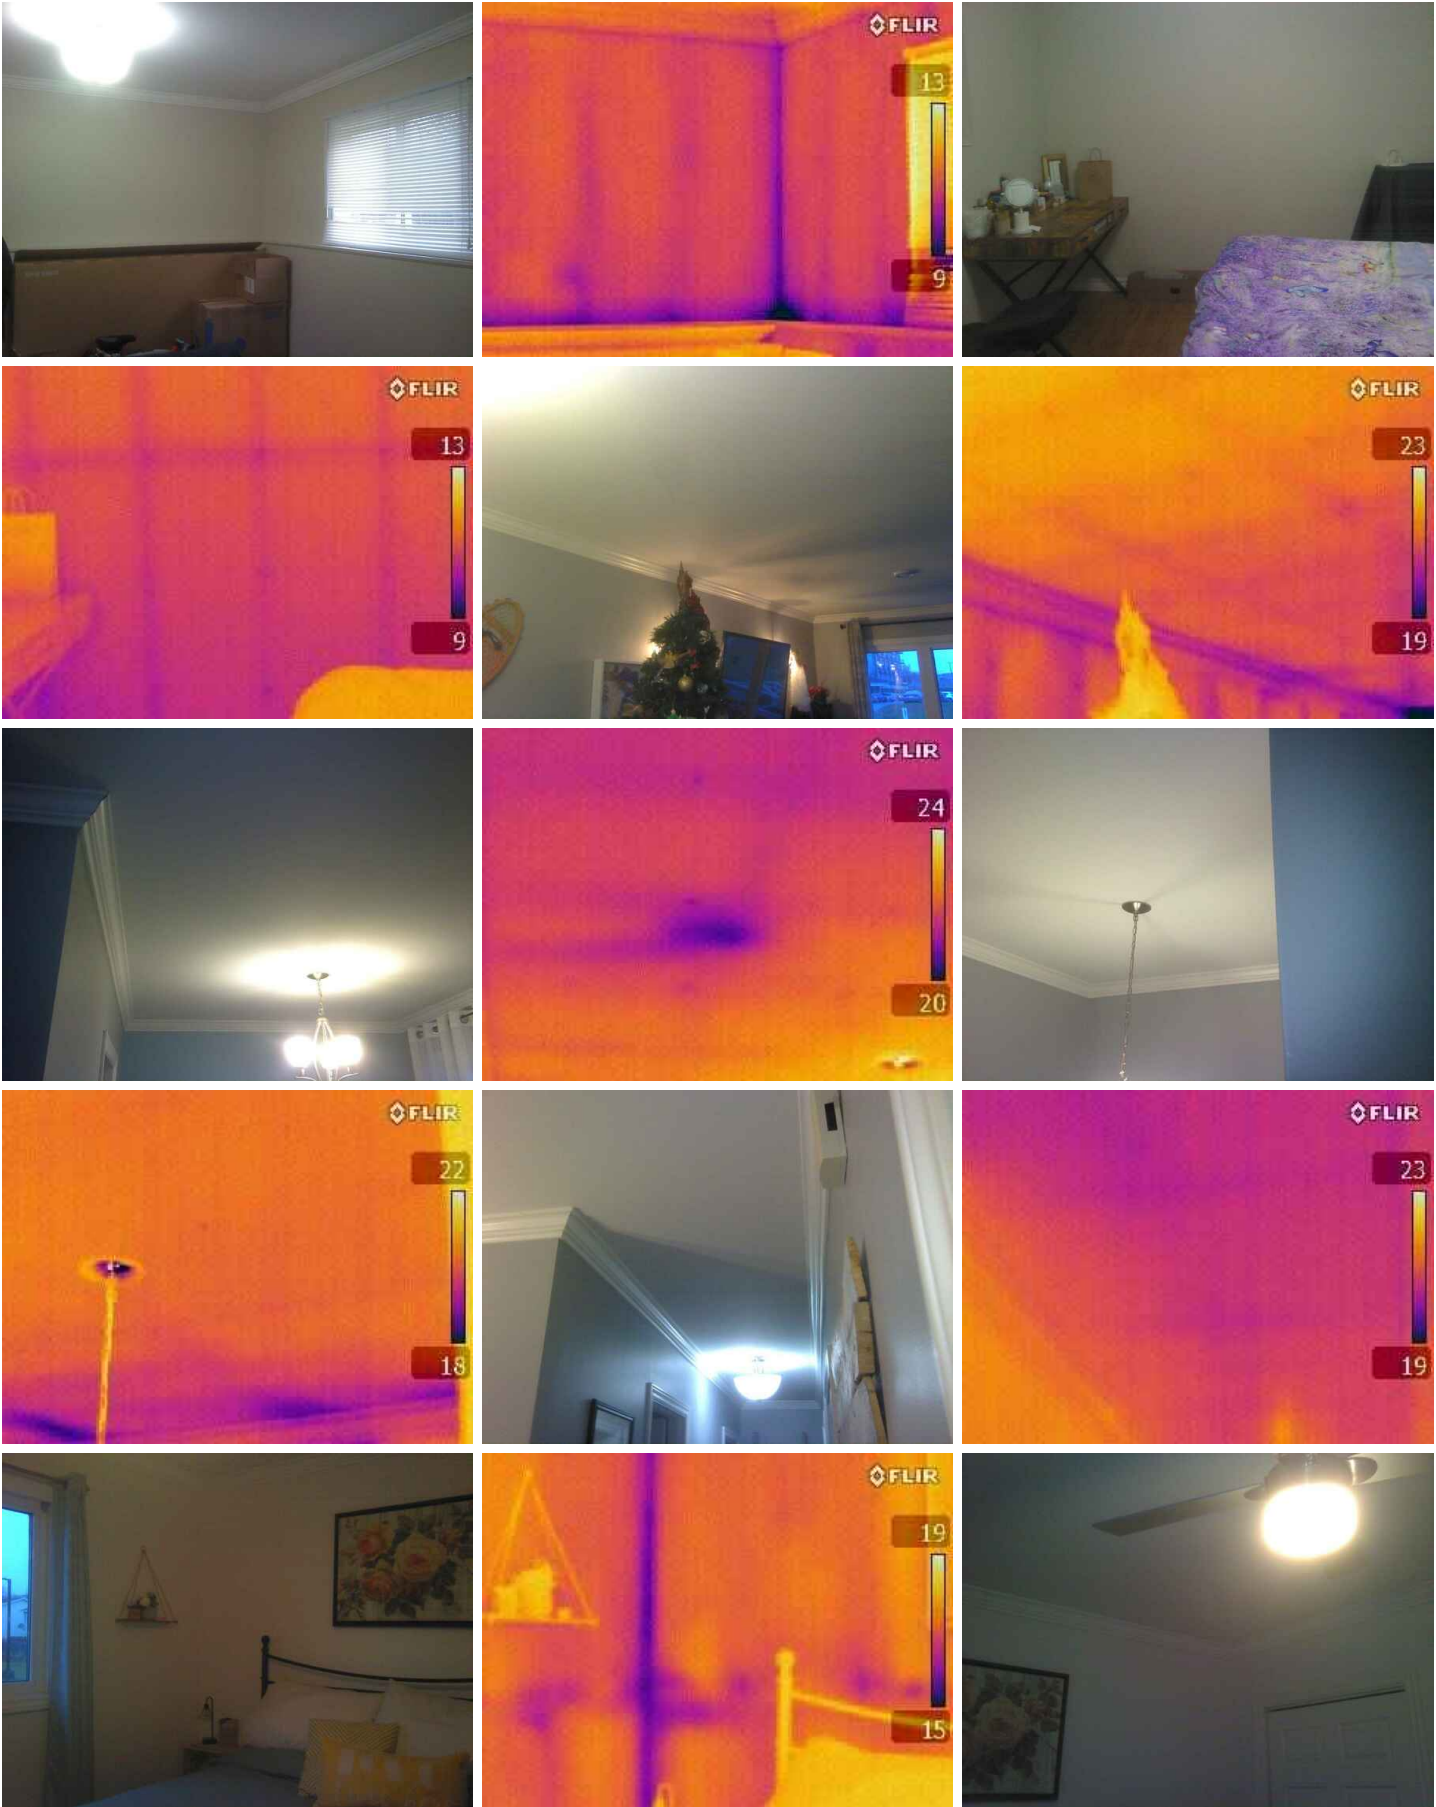
General photos. Typical gaps or voids observed at some locations. This is a common occurrence due to the age of the home. Images provided for informative reasons.
