# Safe and Sound Residential Inspection Ltd. Inspection Report

Main Road, Anytown, NL

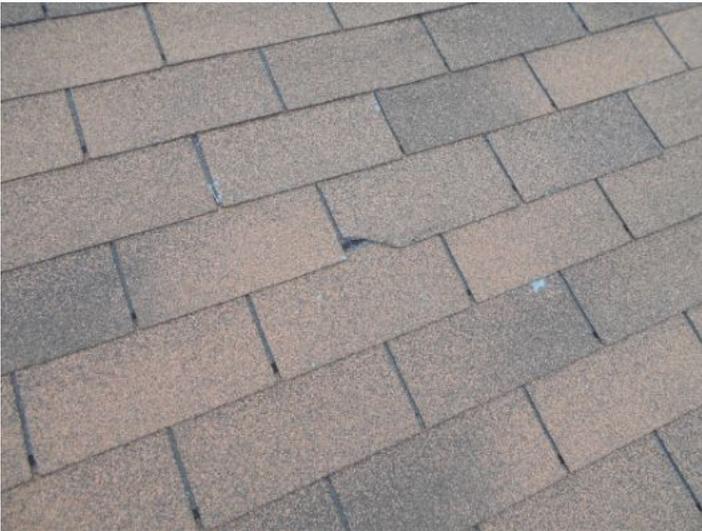
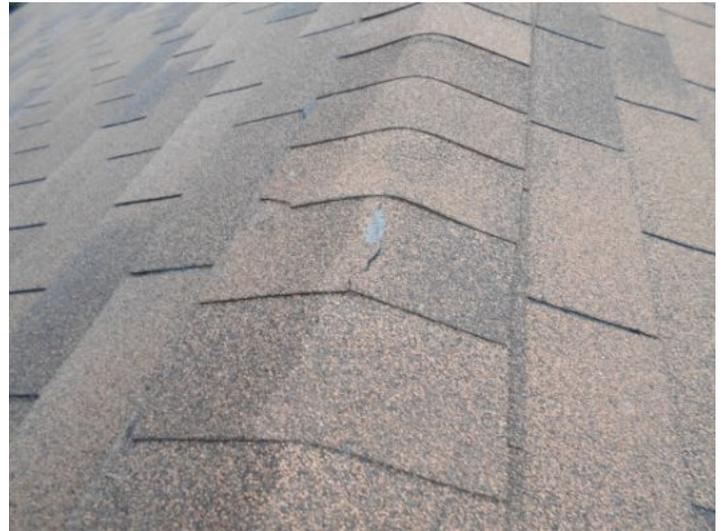
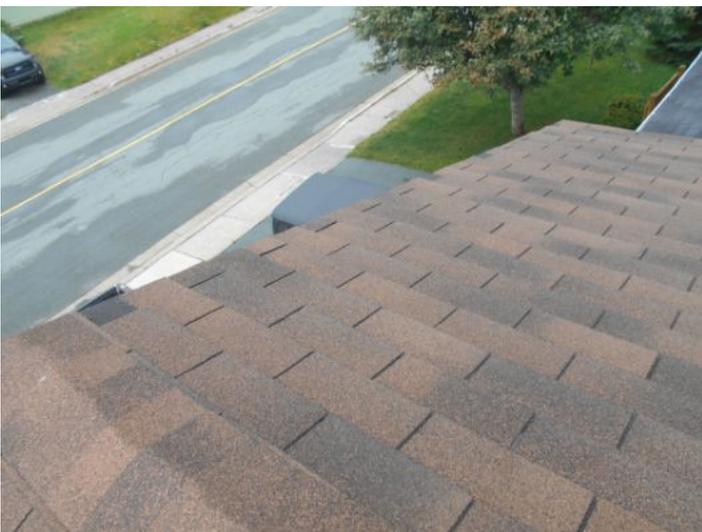
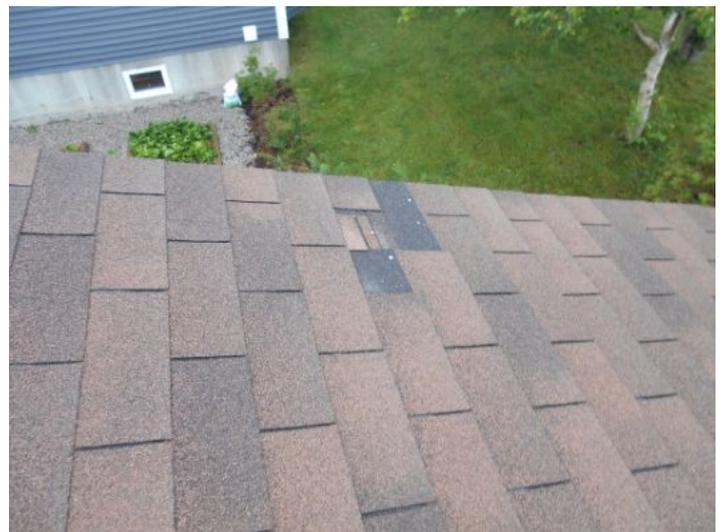
### 4. Soffit & Fascia

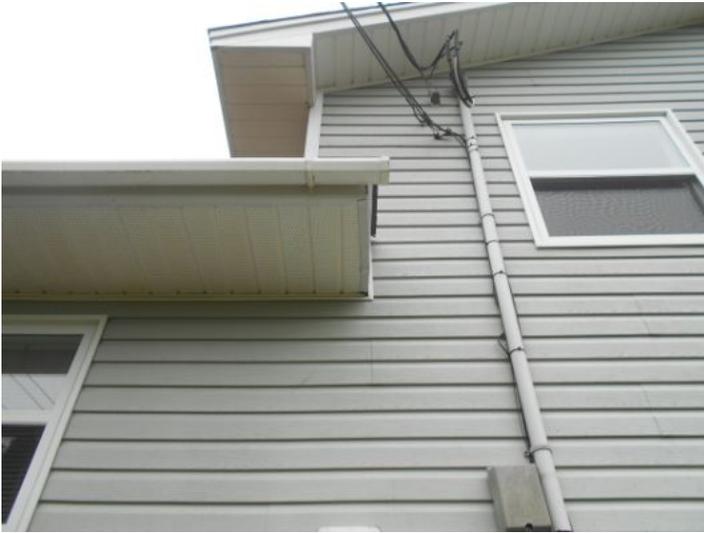
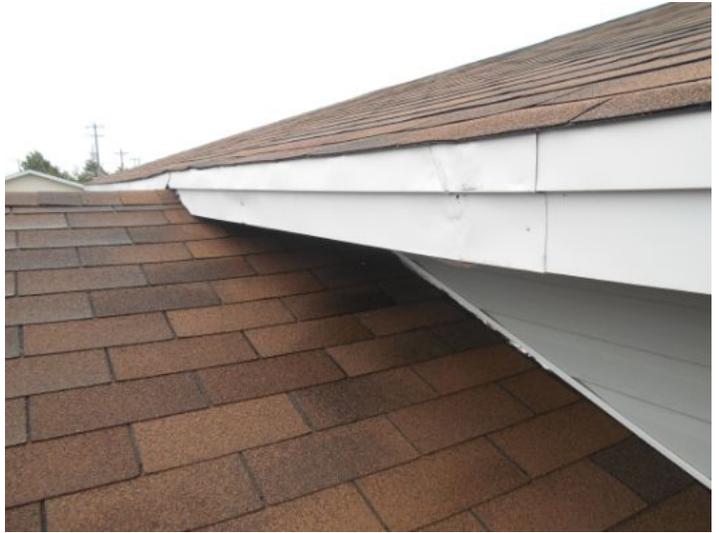
5. General Condition Photos

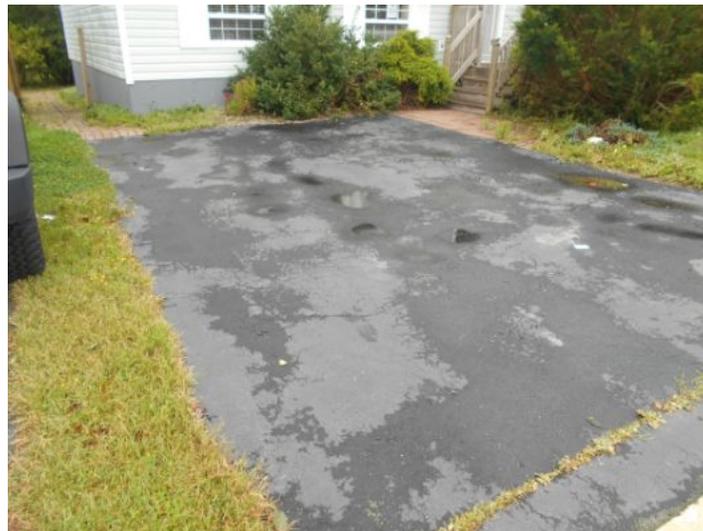
Observations: Driveway covering worn/uneven. Noted for safety.

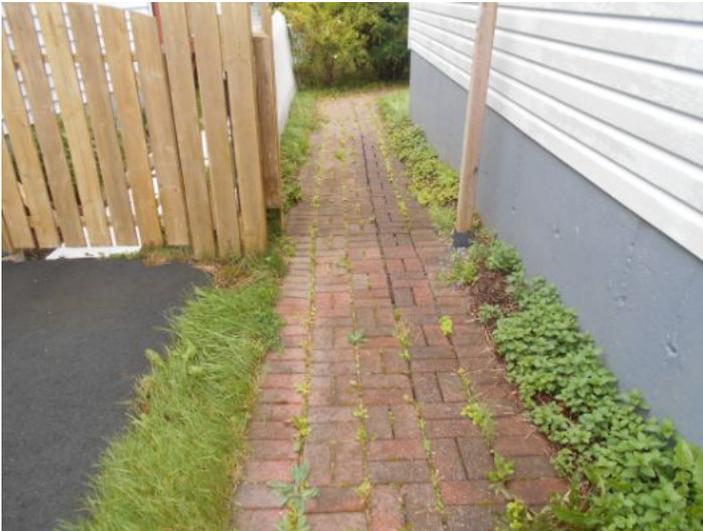
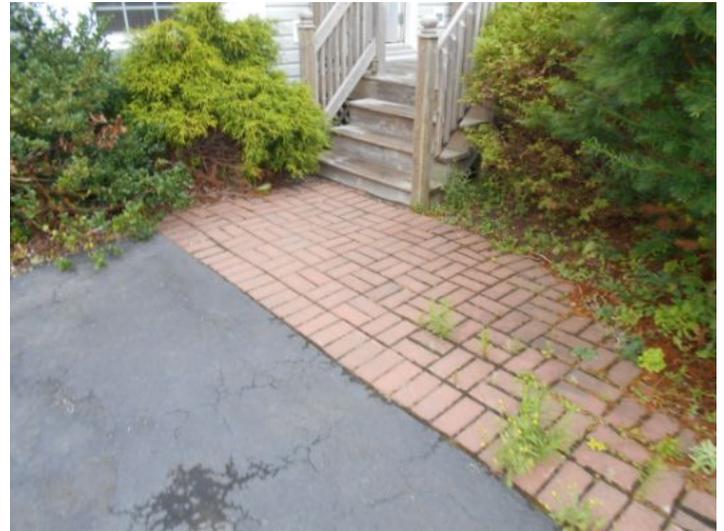
#### 4. Exterior Cladding

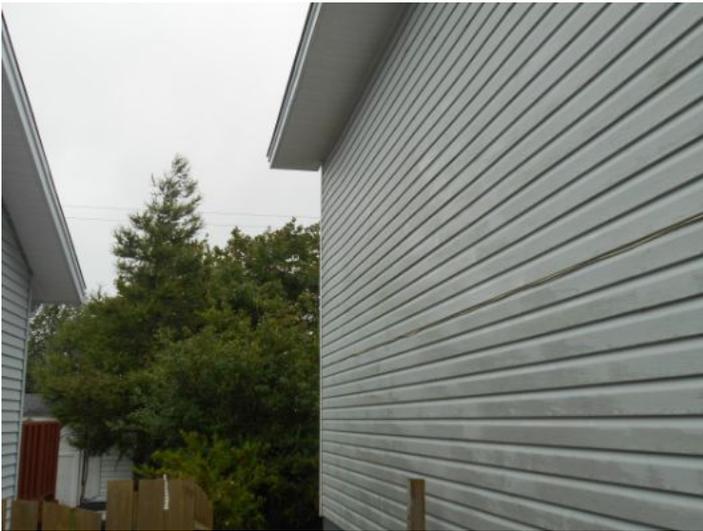
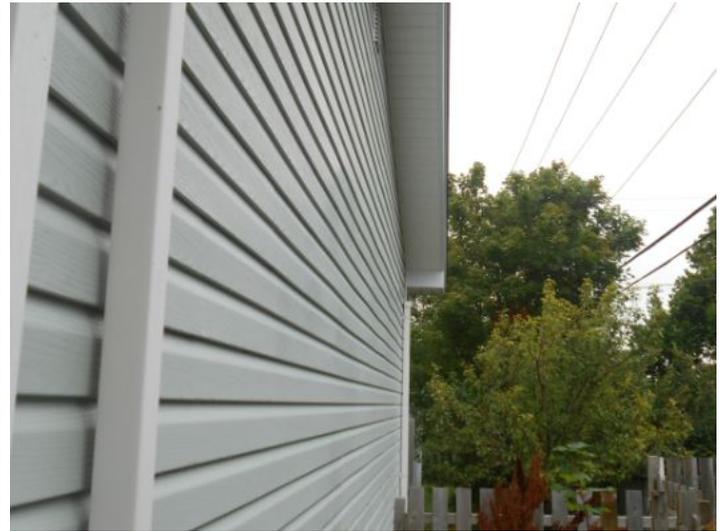
Observations: Cladding surface wavy/buckled (slight). This is a common observation. Noted for client convenience.

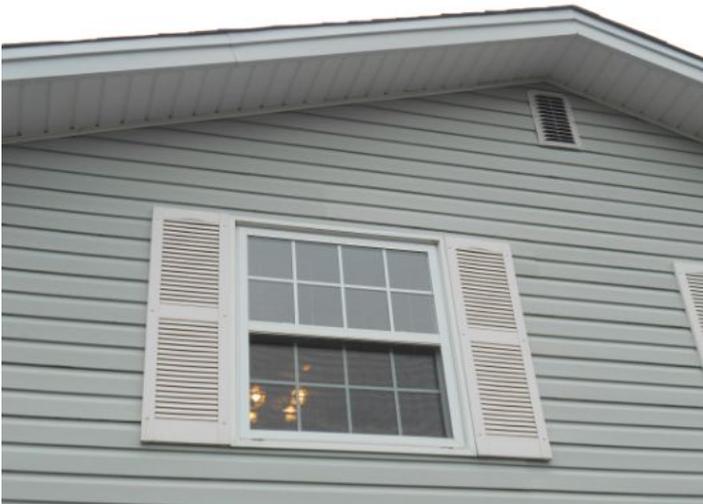
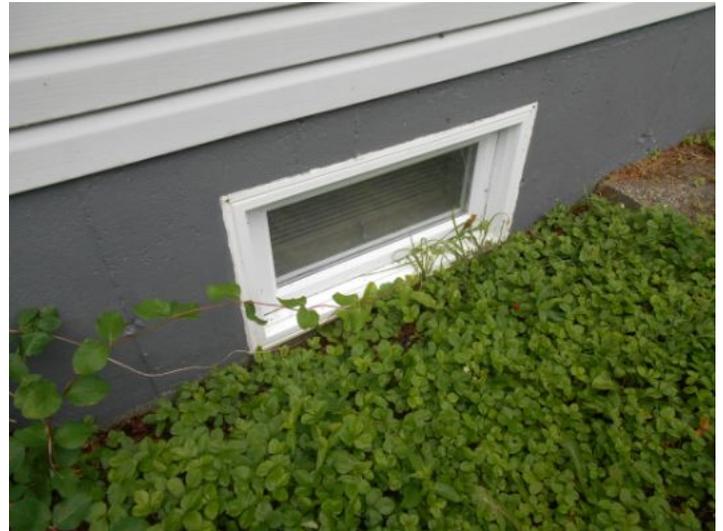
## 7. Exterior Doors

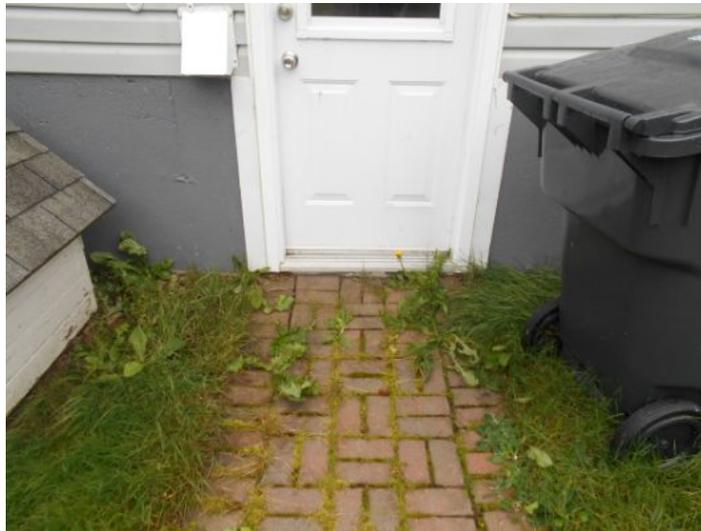
Observations: Exterior Door(s) sill closer to grade than recommended. May increase susceptibility to moisture entry and/or reduced service life. Note: This is a common observation based on the age of home.

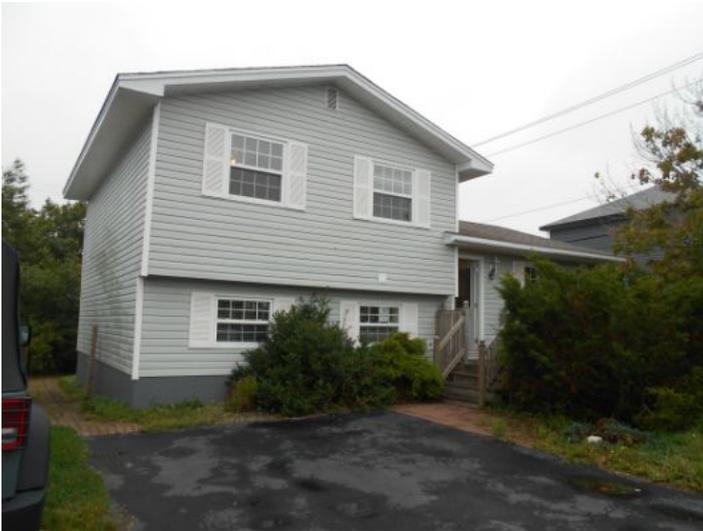
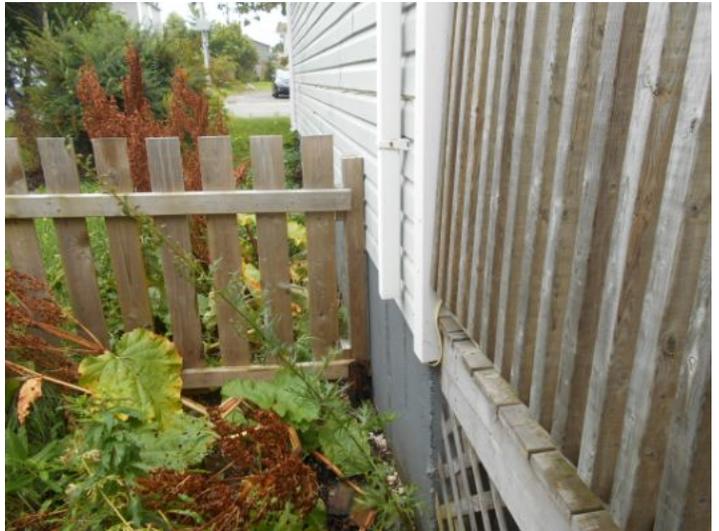
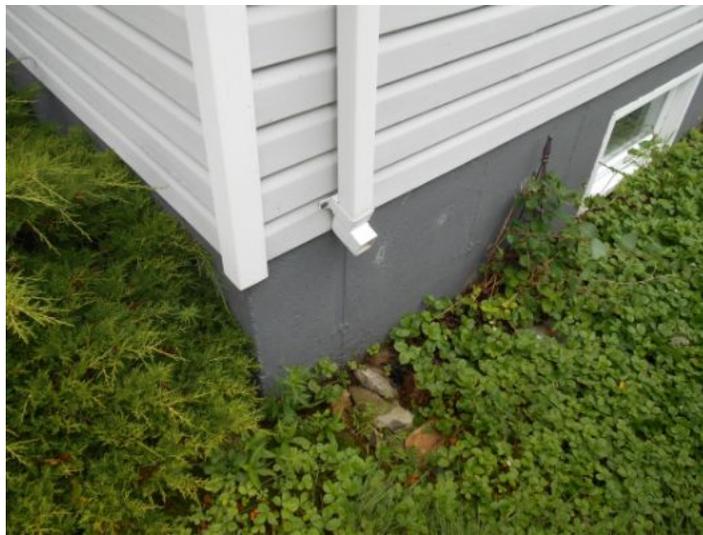
Note: Evestrough not present at upper roof surfaces. Consider installation to prevent premature wear of lower roof coverings, in addition to directing surface water away from foundation walls.

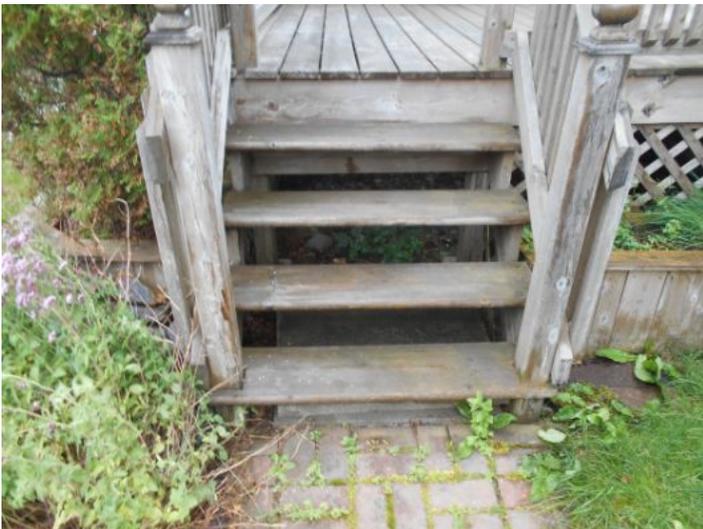
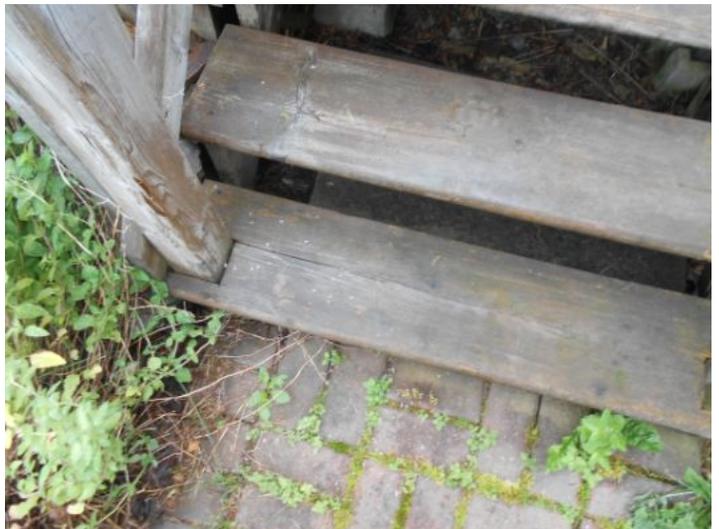
Observations: Rear stair tread damaged. Thickness of treads less than recommended. Movement observed at post caps. Recommend correction for safety.

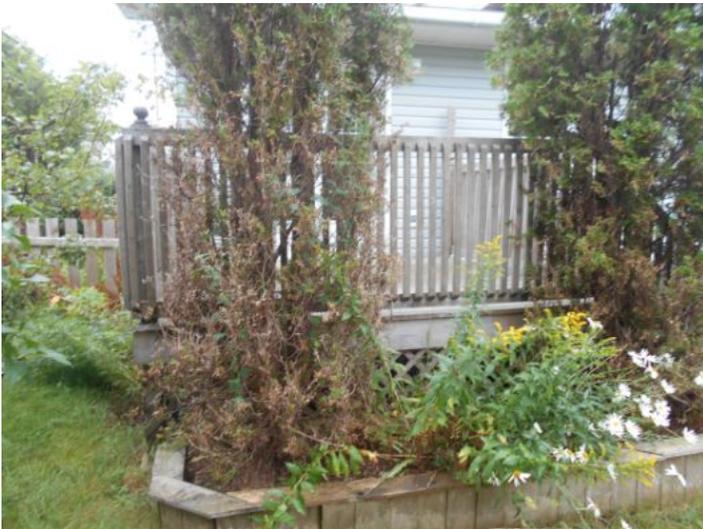
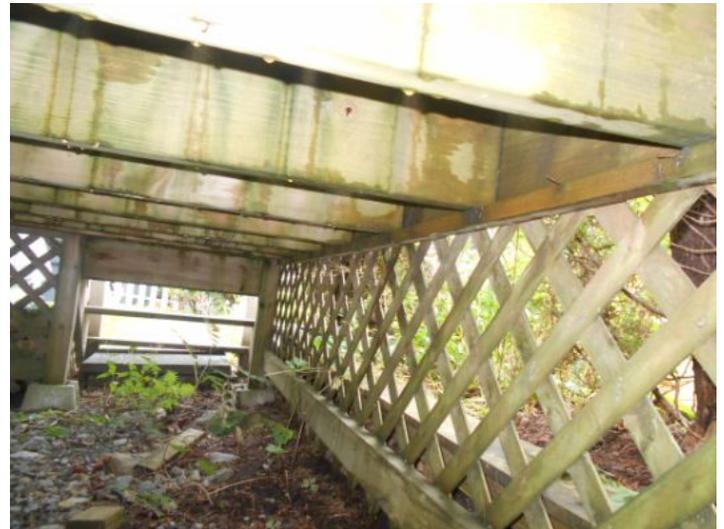
Deck/front step surfaces not level (slight). Noted for convenience.

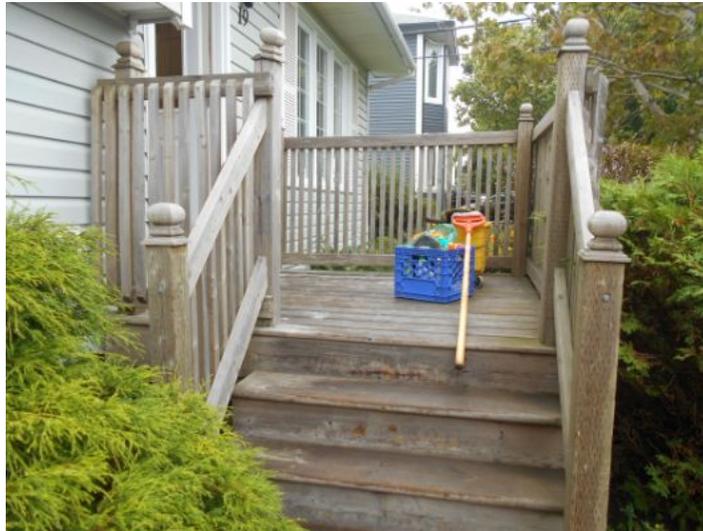
## 12. General Exterior Comments

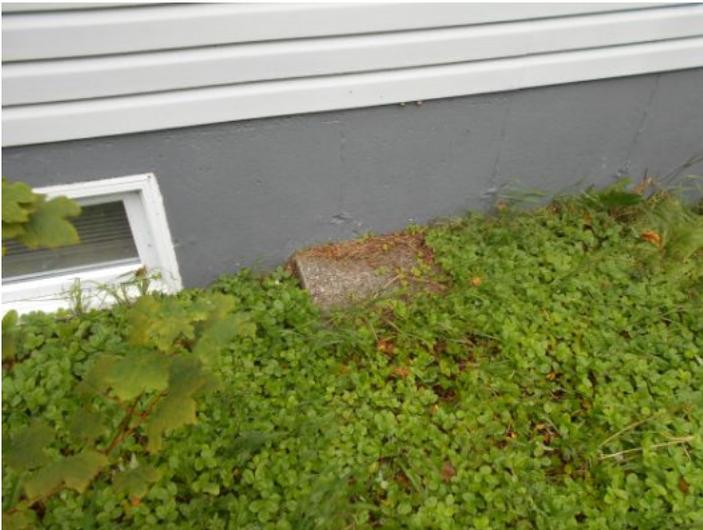
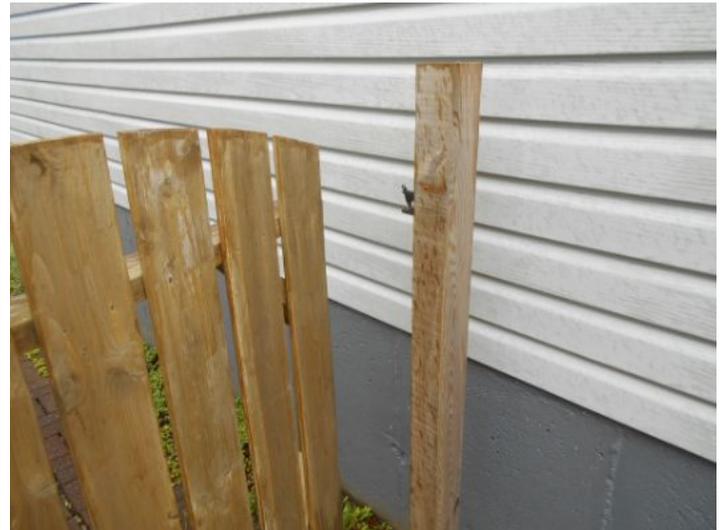
Unused weather hood present. Consider removal/enclosing opening if not to be utilized.

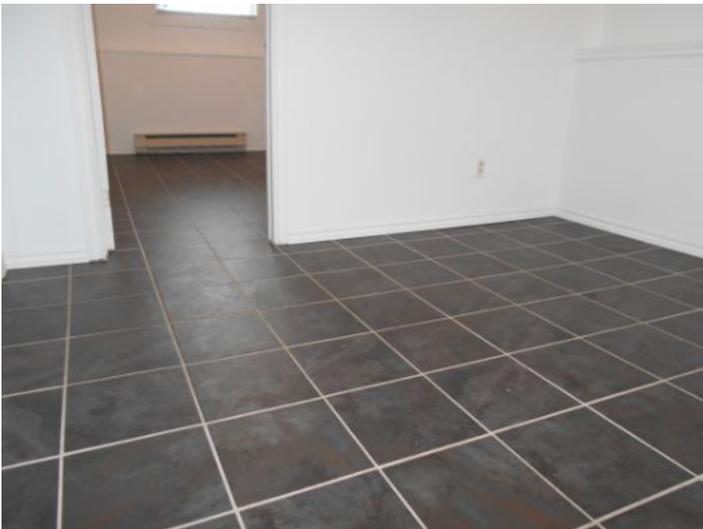
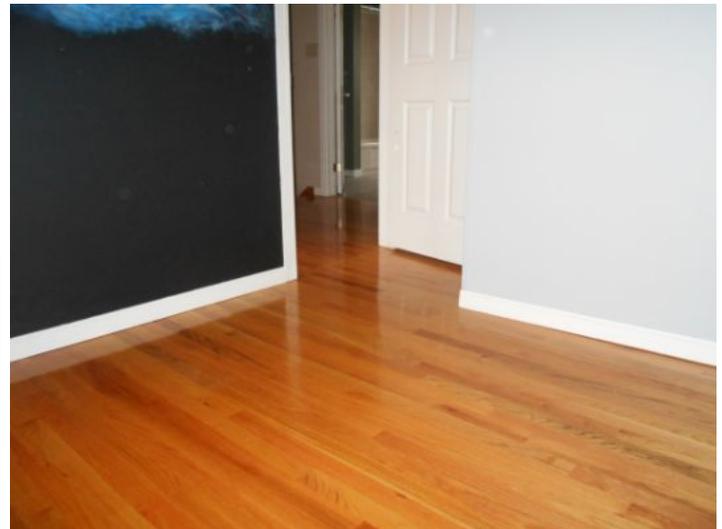
Observations: Floors/framing appear not plumb/level at some areas (slight). This is a common observation based on the age of the home. Noted for client convenience.

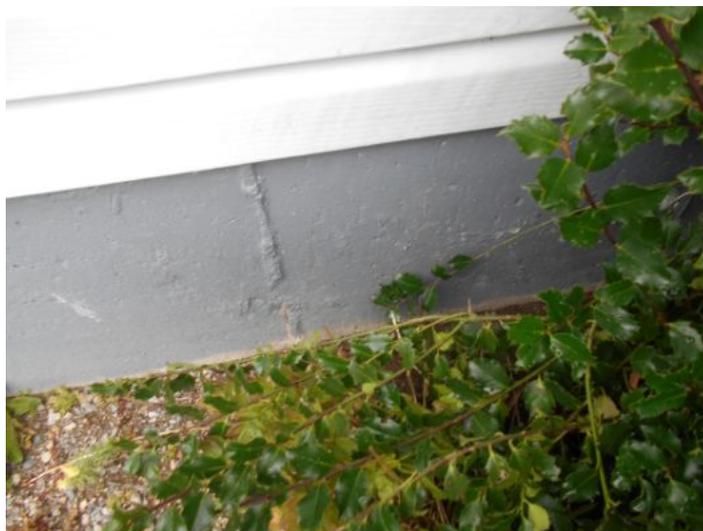
## 6. Floor Structure

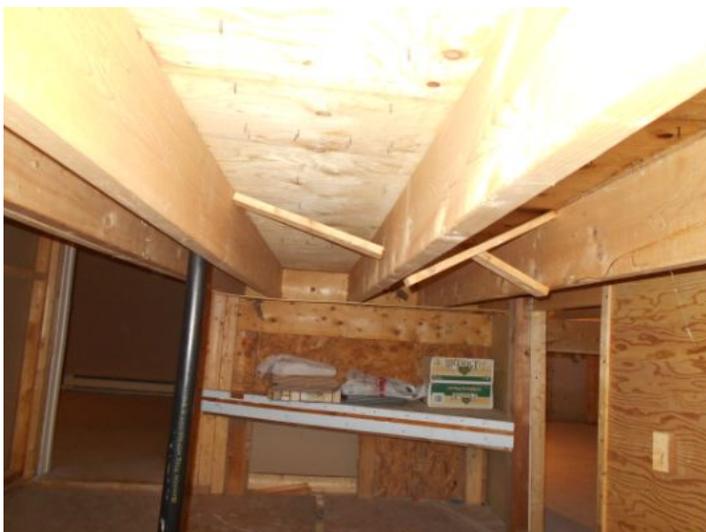
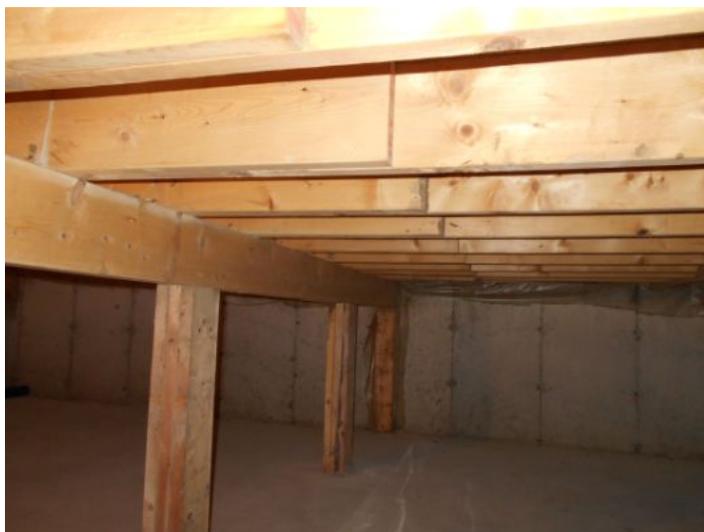
## 7. Wall Structure

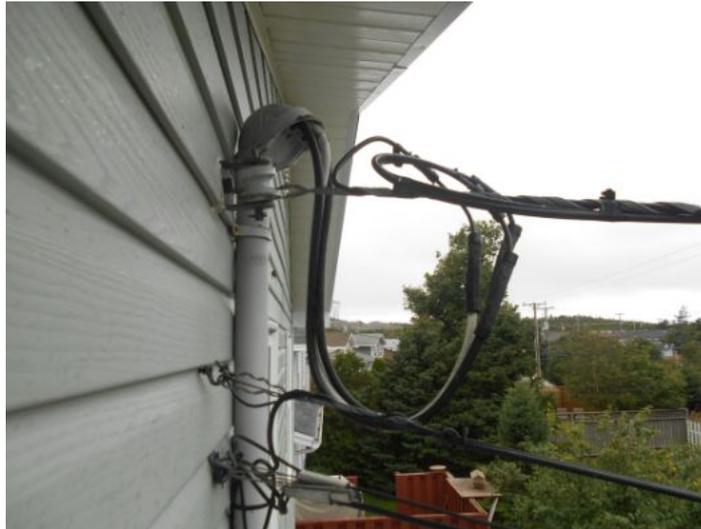
White (neutral) service entrance cable plastic coating shows signs of wear and/or cracking from weathering (typical due age of home). Recommend improvement as needed by licenced electrician.

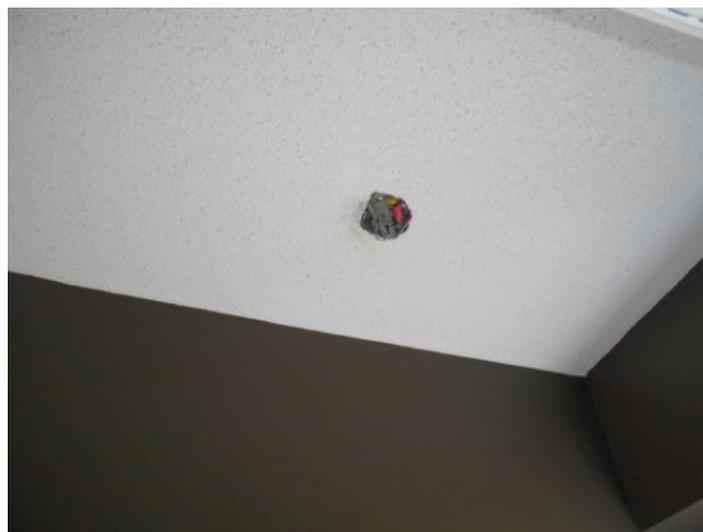
Observations: Cover not present at junction box. Recommend providing for fire safety. Note: Appears a light fixture was previously installed at this location. Consider installation of a suitable fixture provided that adequate combustible clearance can be maintained when the door is opened below the fixture.

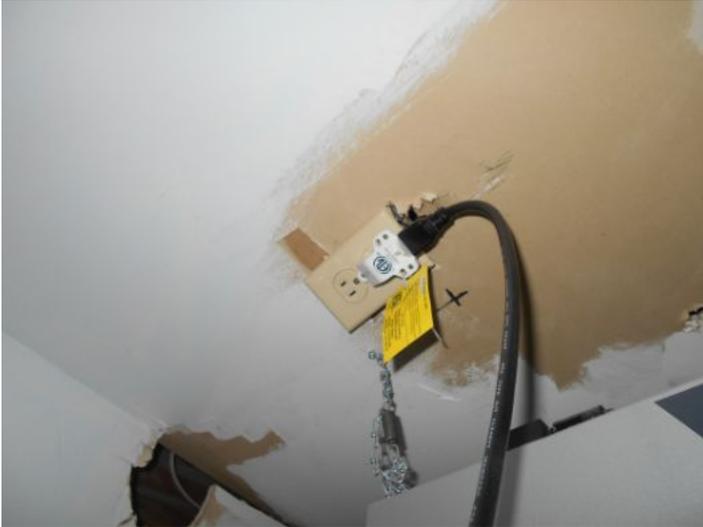
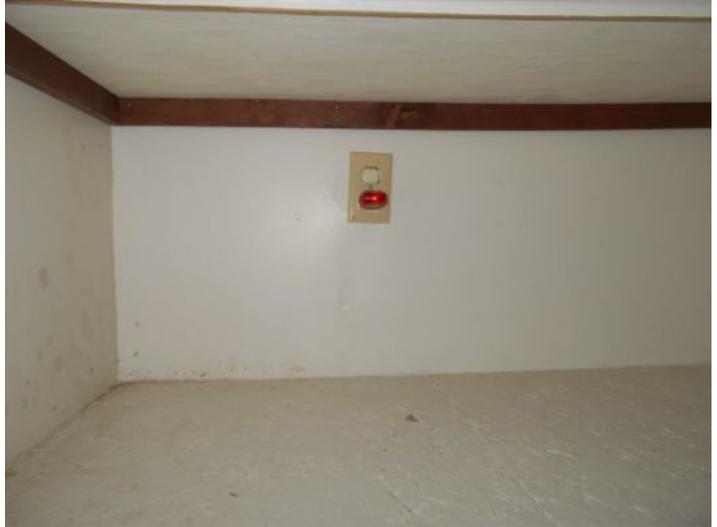
Observations: Outlet(s) not secured/movement noted. Outlet tests reverse polarity. Recommend repair by licenced electrician due to potential shock hazard.

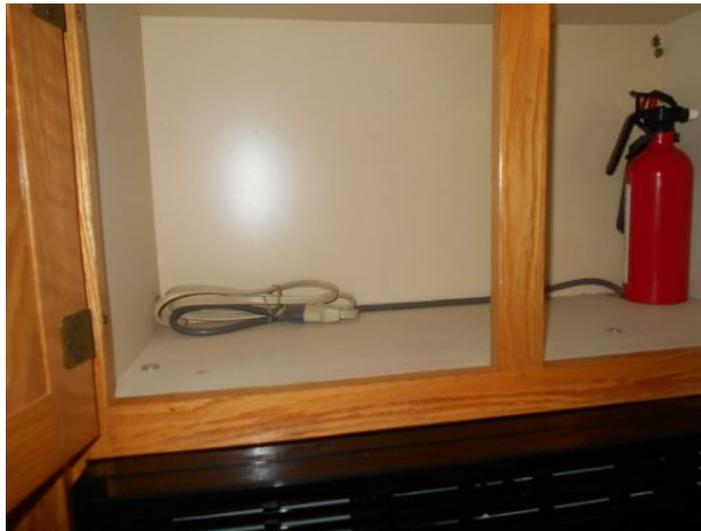
## 11. Indoor Lighting

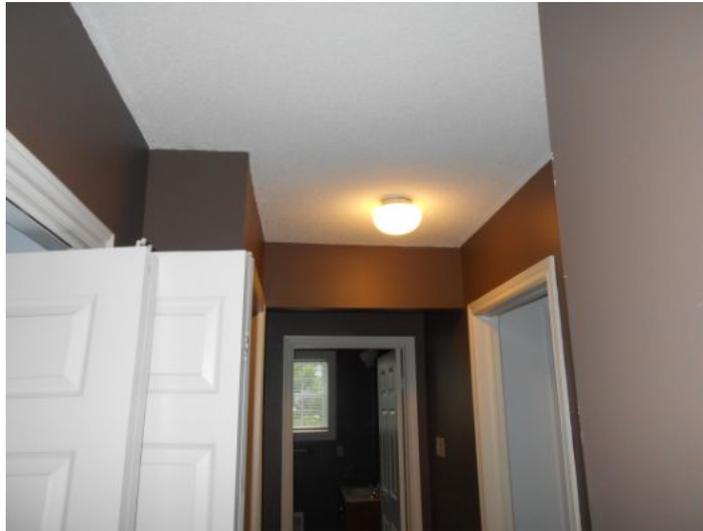
## 12. Smoke/CO 2 detector comments

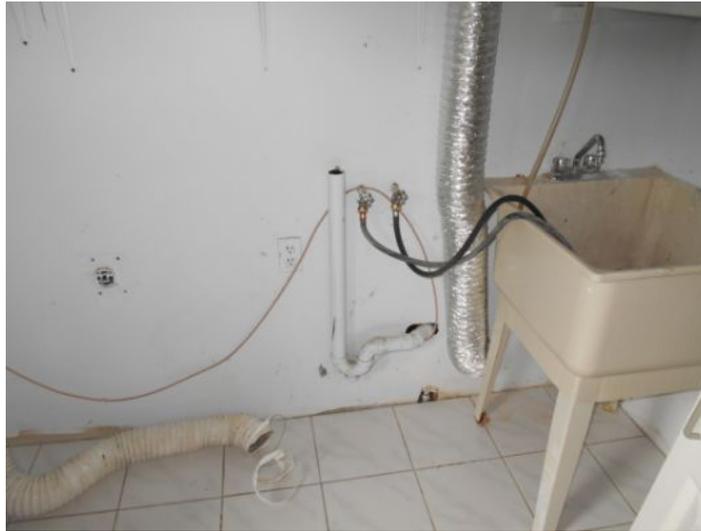
- Storage/appliances
- Unable to evaluate laundry provisions due appliances not present.
- Back water valve condition/performance

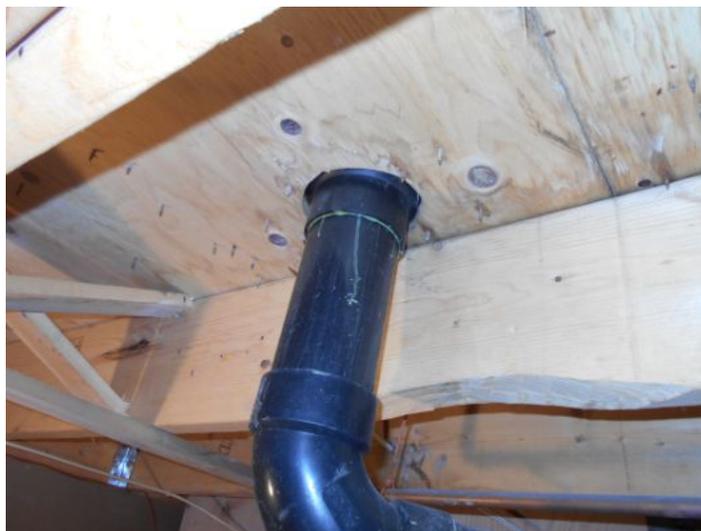
#### 4. Main Shut Off Location

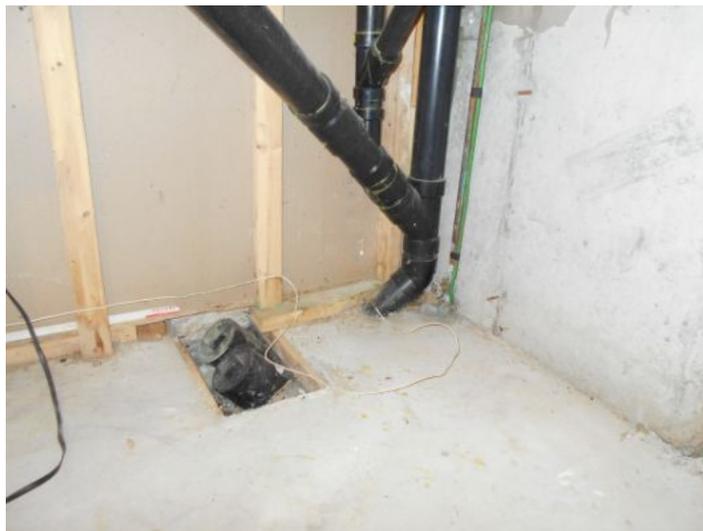
#### 5. Main Waste Clean Out

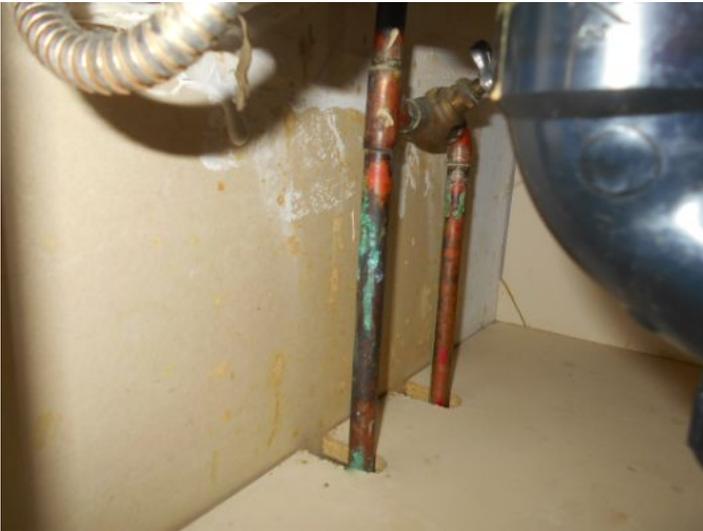
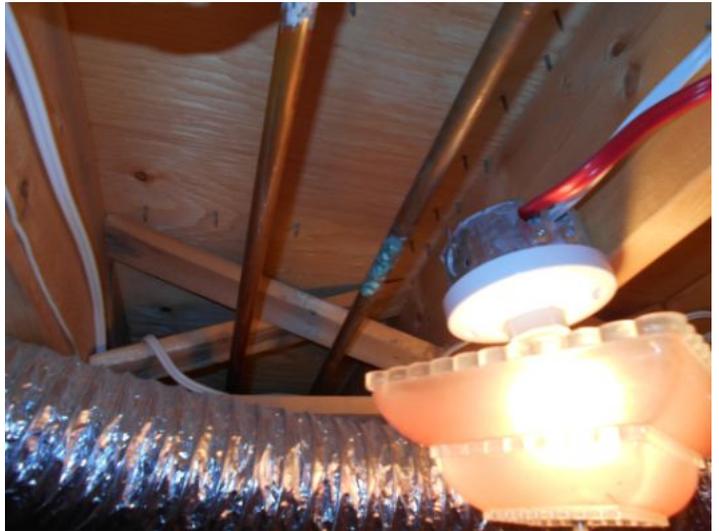
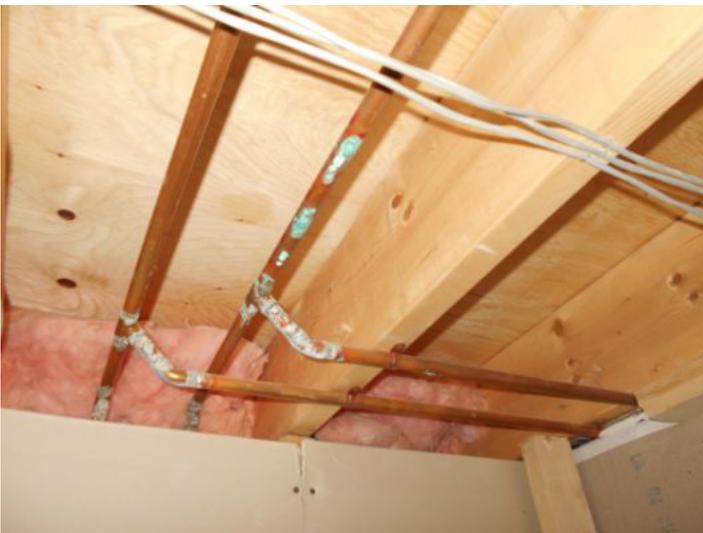
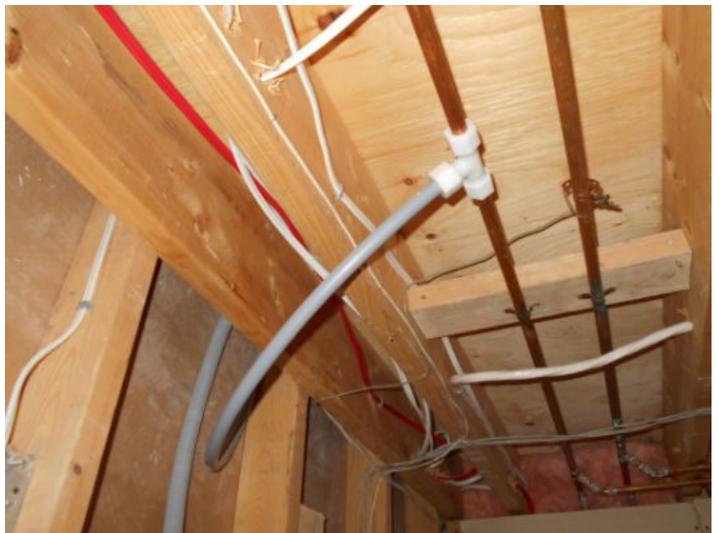
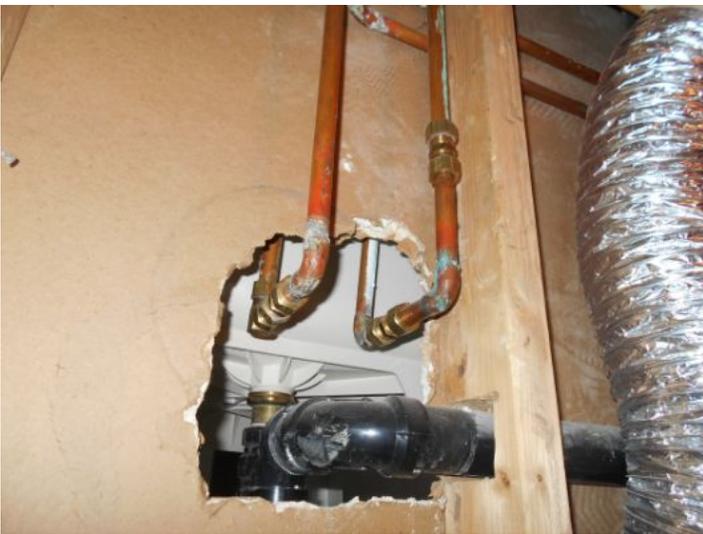
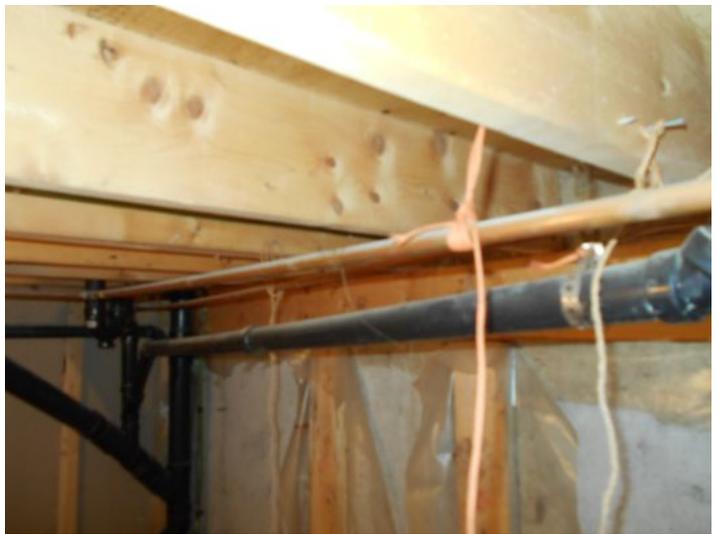
### 8. Waste Plumbing

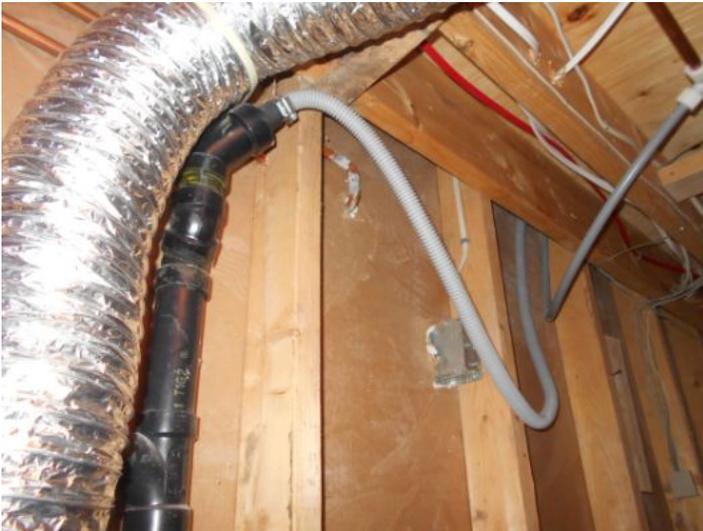
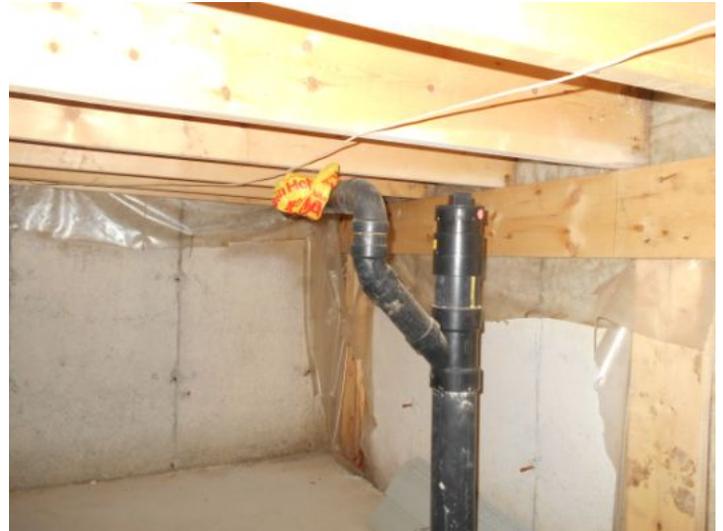
### 9. Bathroom Plumbing

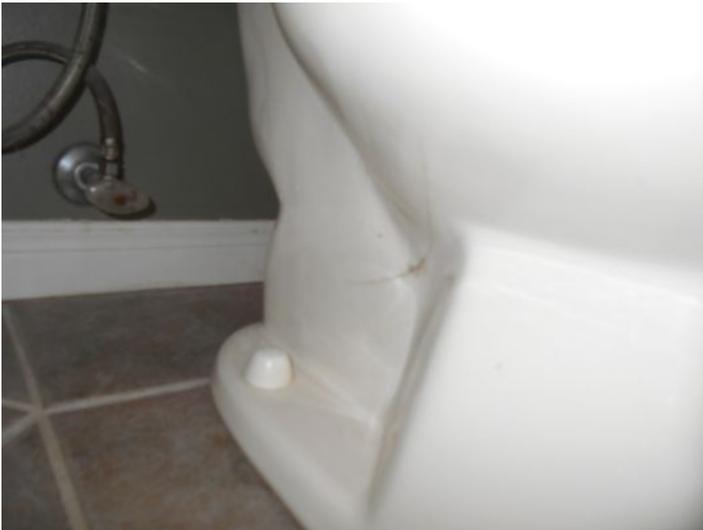
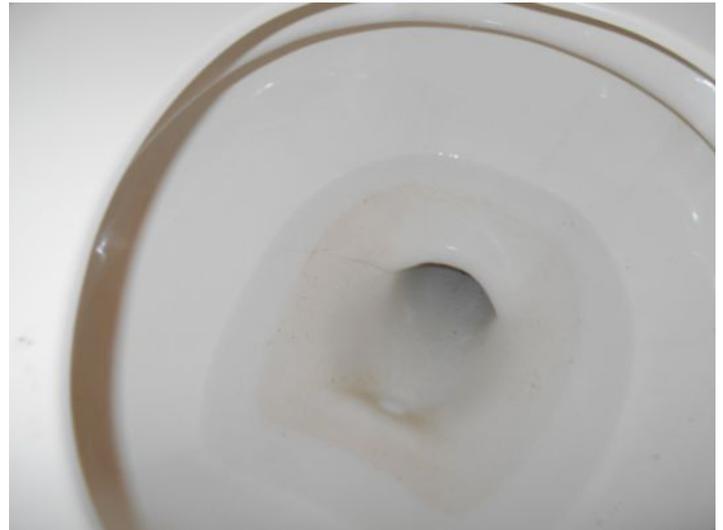
Rust observed at vanity basin drain. Recommend monitoring for future condition.

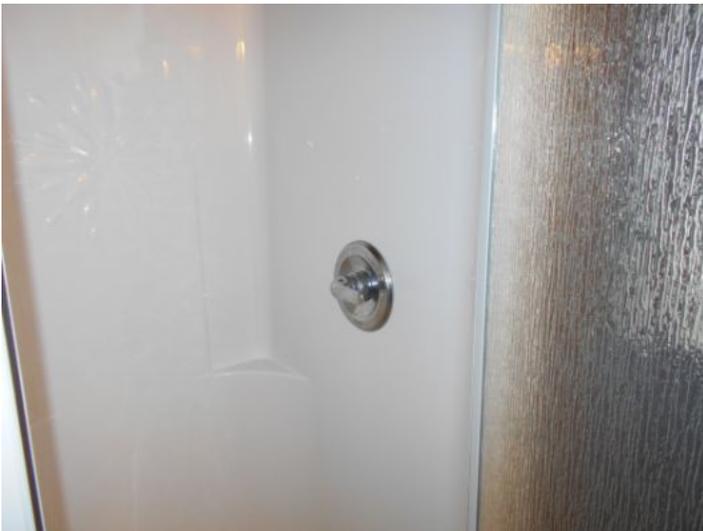
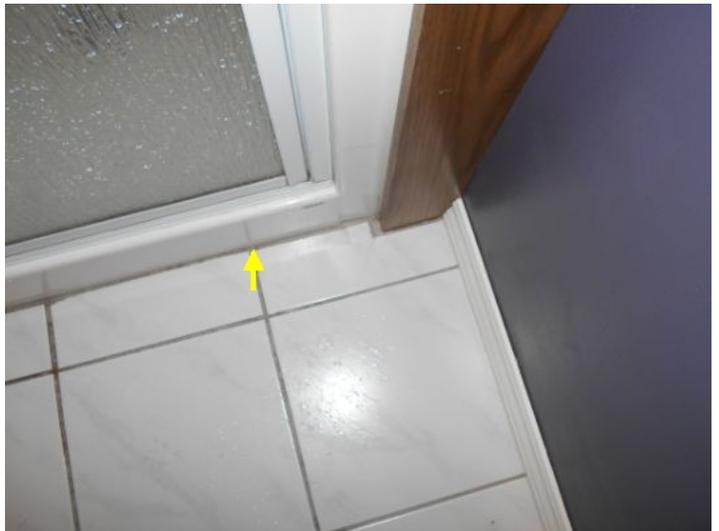
Caulking not present at shower base/floor intersection(s). Suggest providing to aid in prevention of water damage.

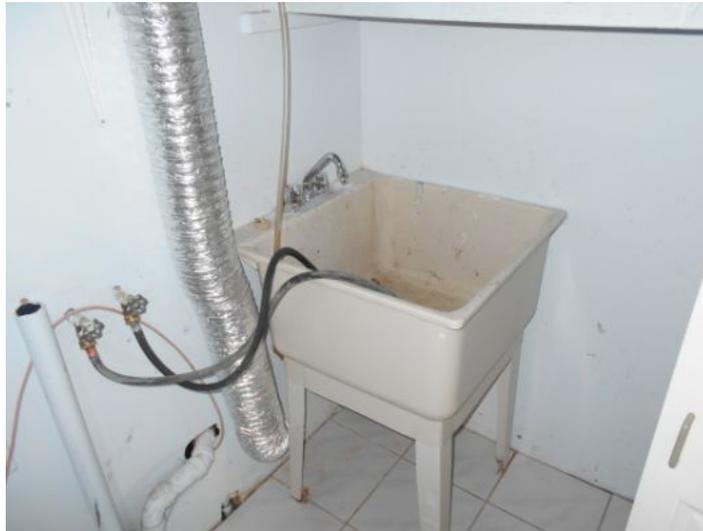
Laundry tub slow to drain. Recommend improvement as needed. Note: Debris/blockage observed at tub strainer.

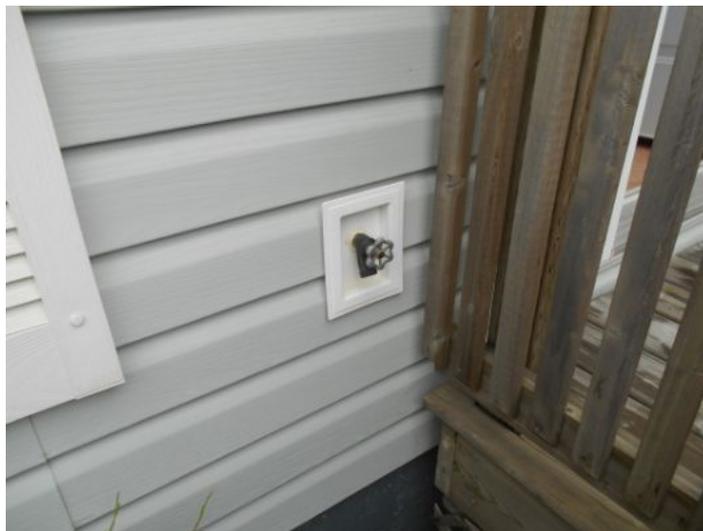
Hose bibb not frost free type (typical based on the age of the home). It is necessary to shut off water supply with interior shut off during heating season to prevent flooding. Noted for client convenience.

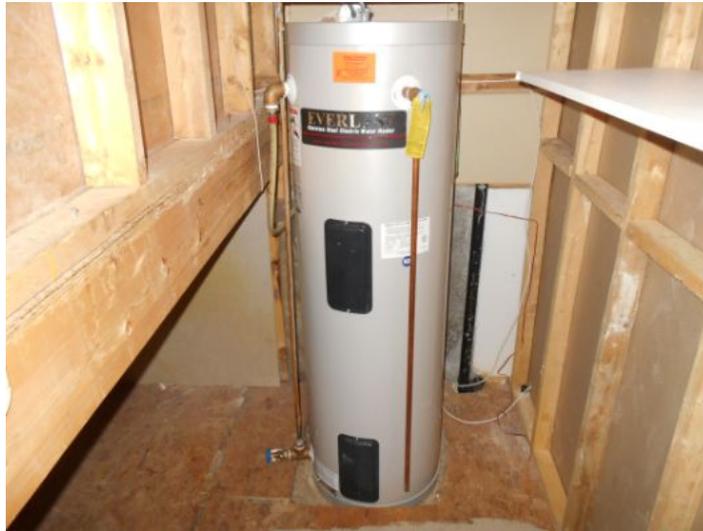
#### 14. Recommendations

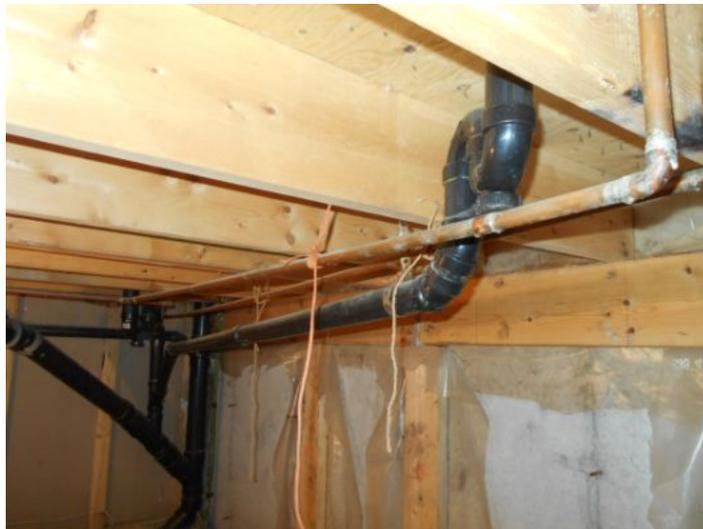
Observations: "S" type waste trap(s) observed. Appears fixture(s) located further than recommended by modern standards from venting. These are common observations based on the age of the home. No functional issues were observed. However, client may choose to consult a licenced plumber for further evaluation/information.

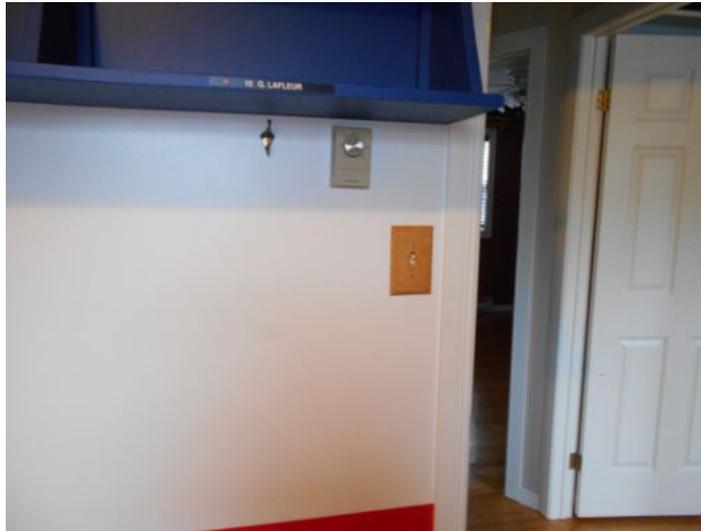
# Mechanical Ventilation

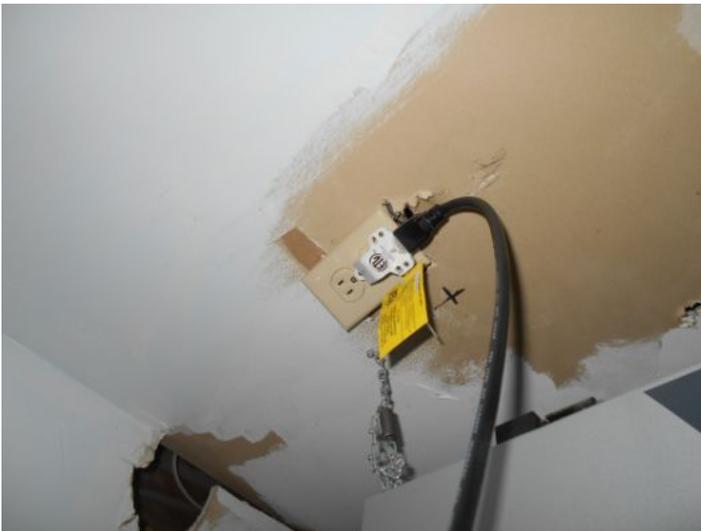
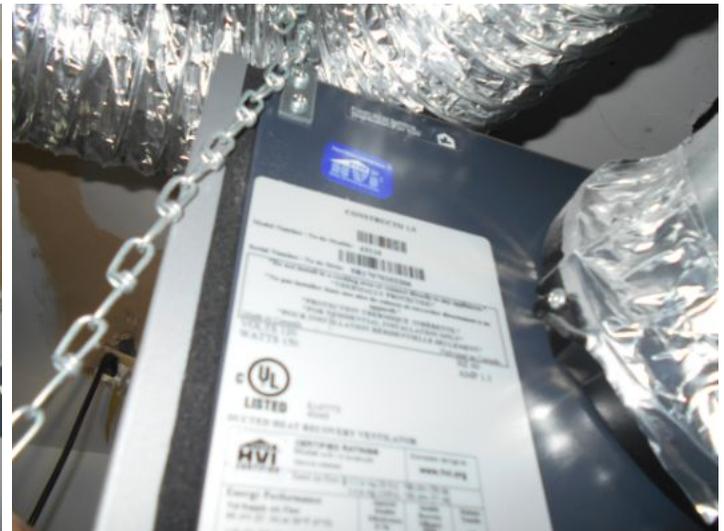
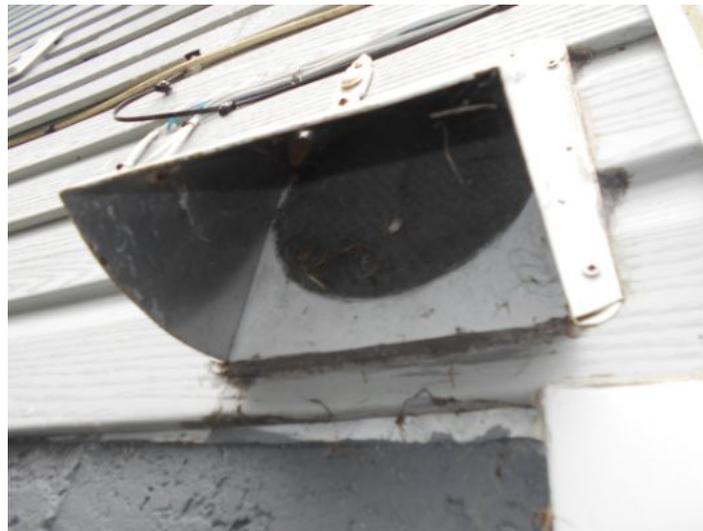
## 3. Heat Recovery Ventilator
