# Safe and Sound Residential Inspection Ltd. Inspection Report

Main Road, Anytown, NL

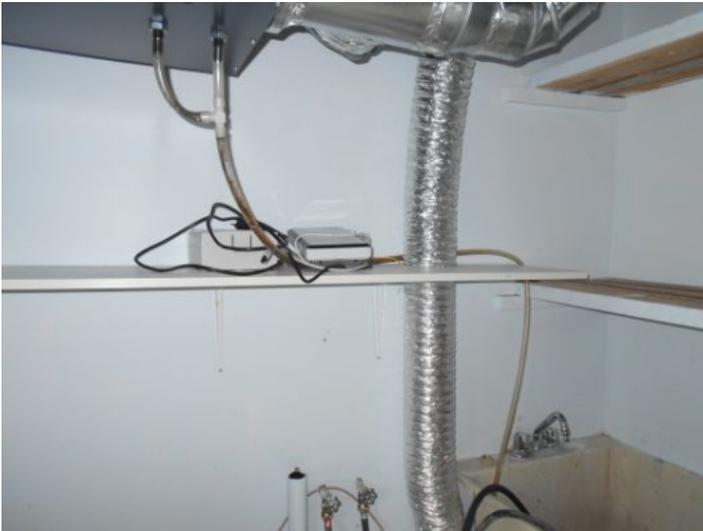
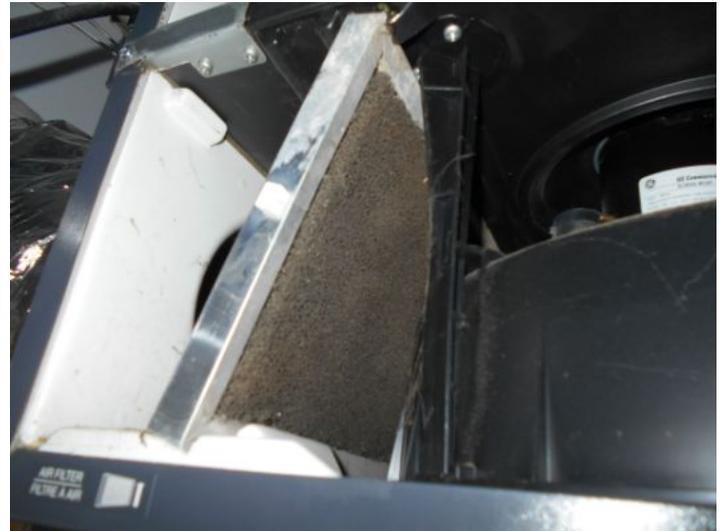
#### 4. Exhaust Type

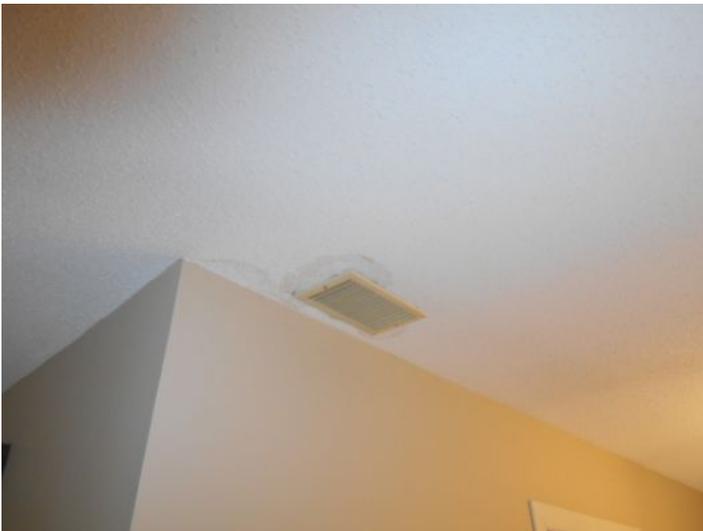
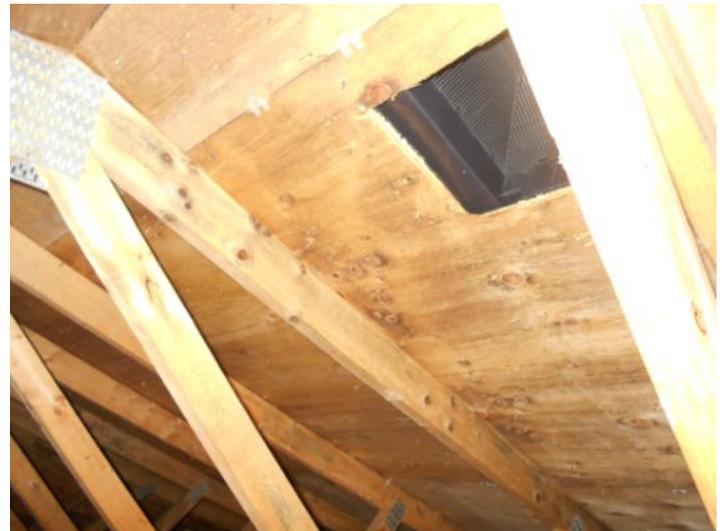
## 4. Attic General Condition

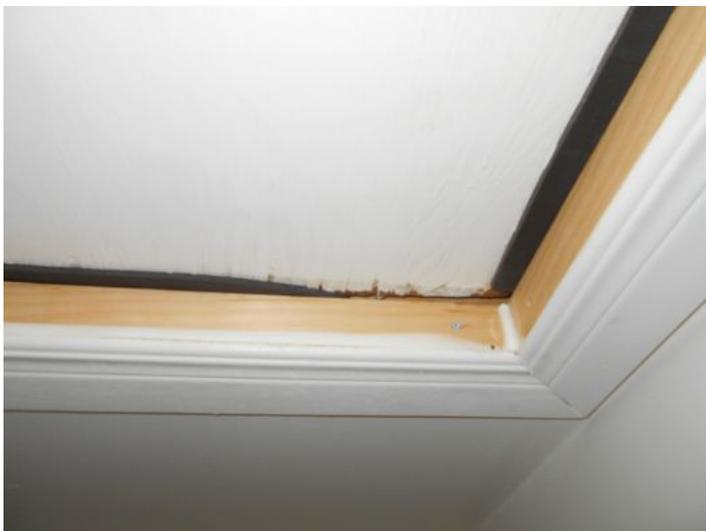
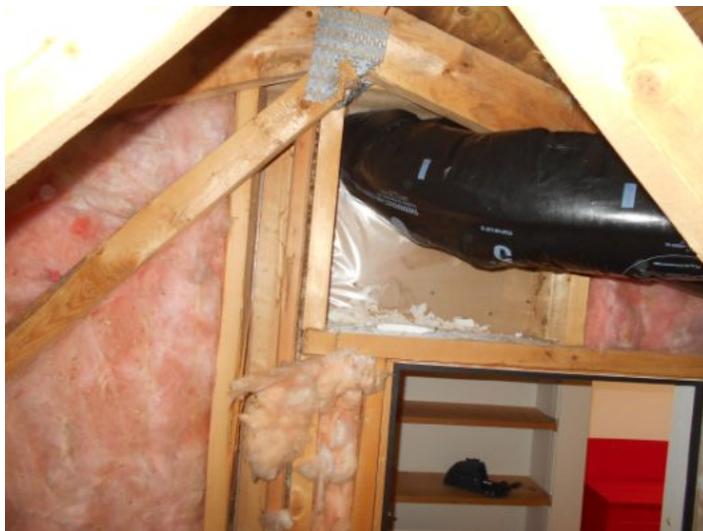
VOIDS observed per example(s). Access hatch weather stripping, and plug securing hardware ineffective. Recommend improvement for efficiency.

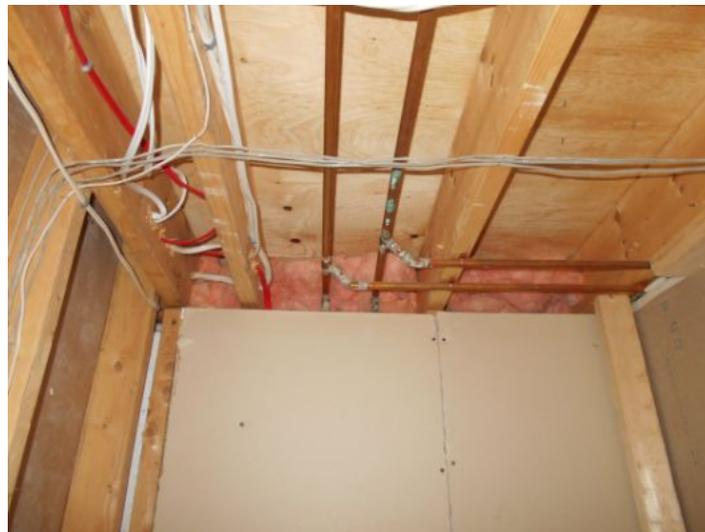
Vapour barrier not present at basement rim joist area. Recommend improvement for efficiency.

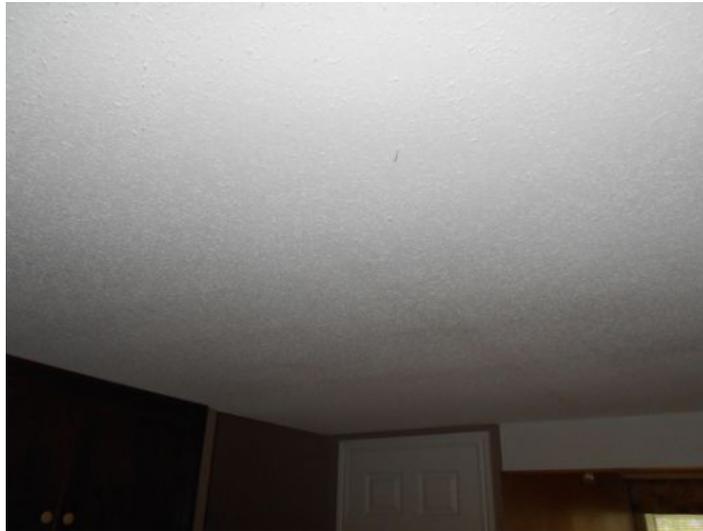
Observations: Staining observed in proximity of supply plumbing. No moisture detected at time of inspection. Refer to supply plumbing comments.

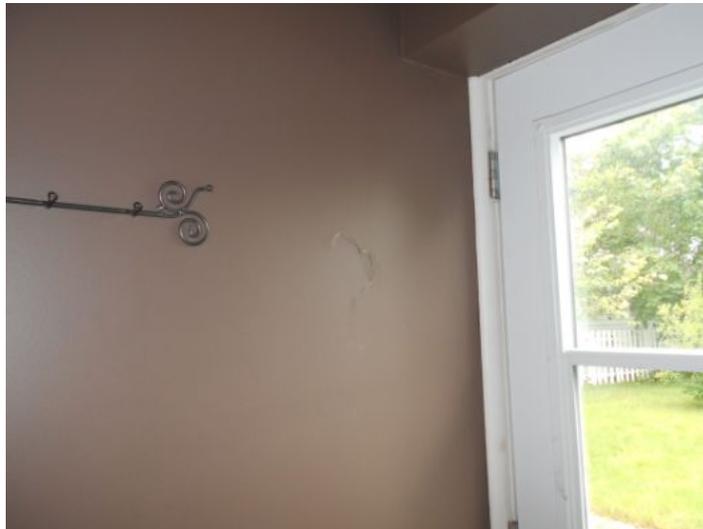
## 6. Floor Conditions

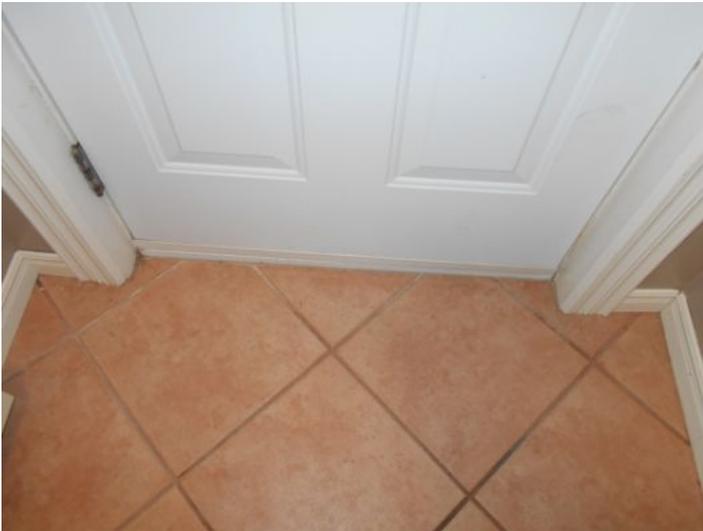
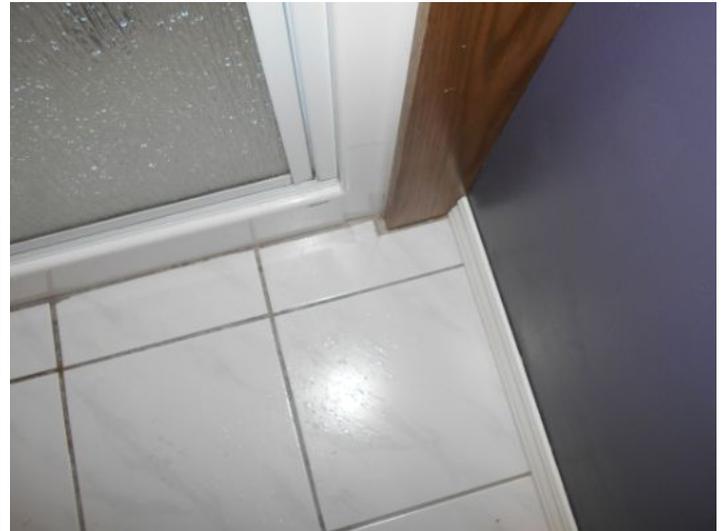
## 7. Window Description

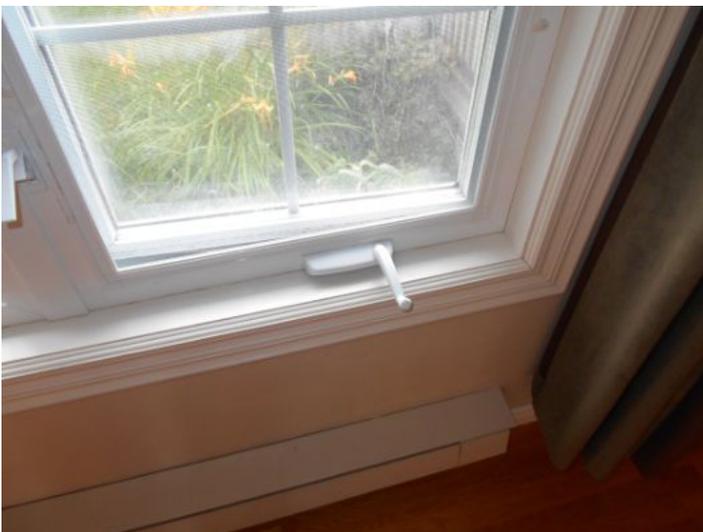
Window opening dimensions at lower level room(s) less than modern egress requirements if intended for use as a bedroom. (Rooms presently utilized for other purposes). Noted for safety.

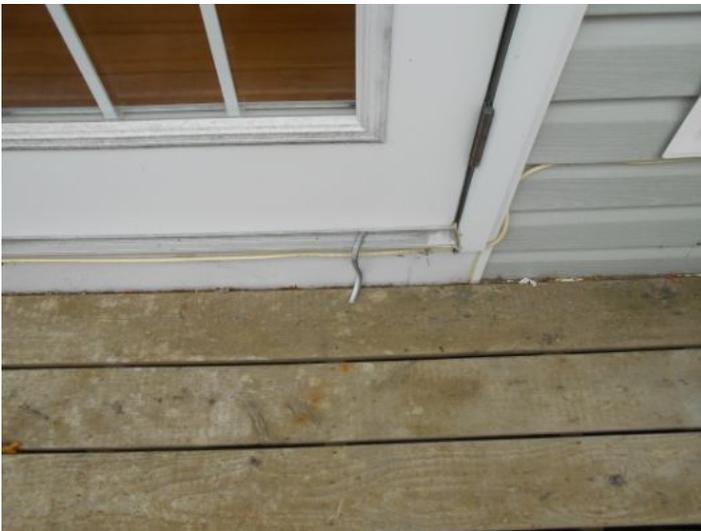
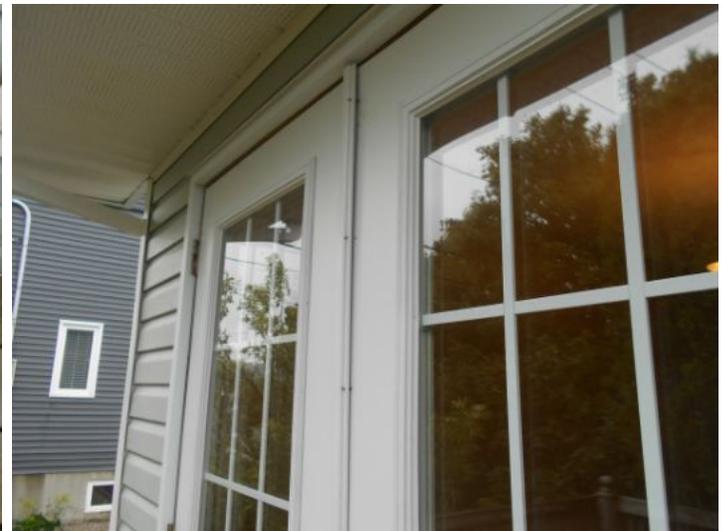
Safety chain (wind) not present at outswing door(s). Suggest installation to minimize the potential for wind damage.

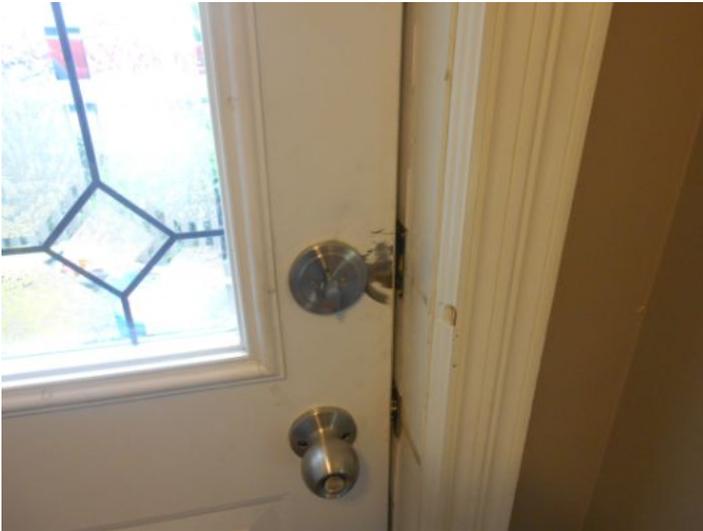
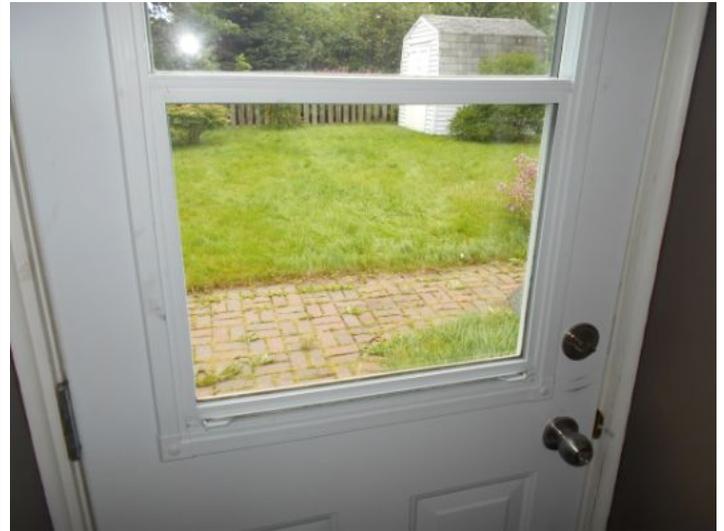
### 10. Interior doors

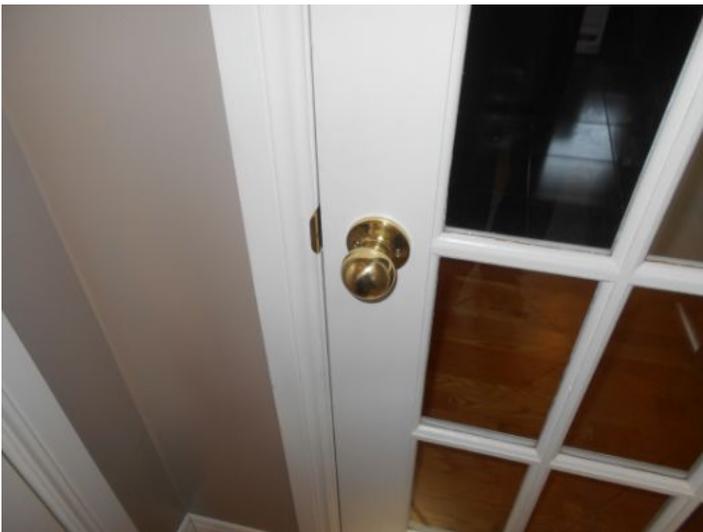
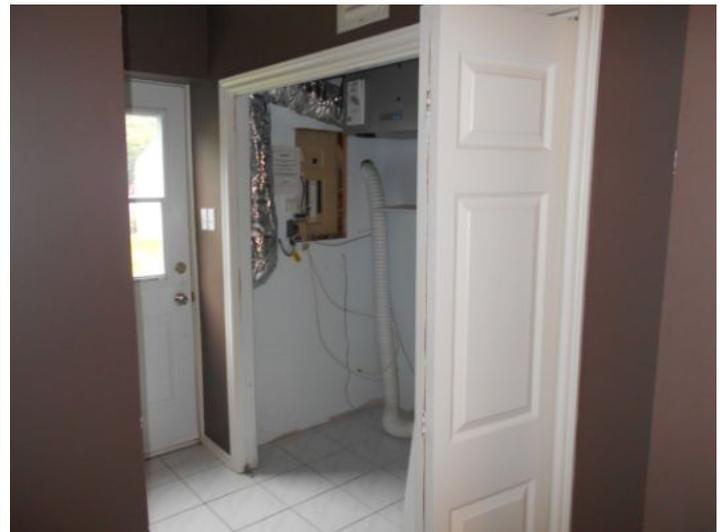
Door stop(s) not present. Suggest installation to prevent damage to finishes.

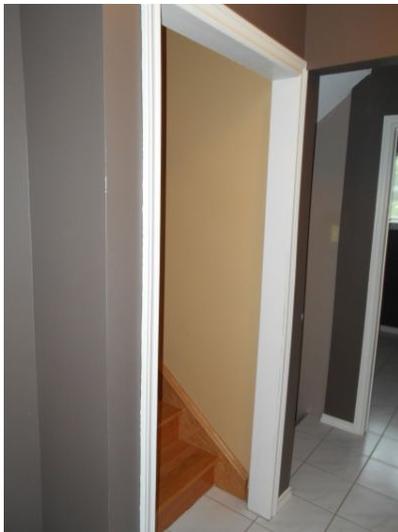
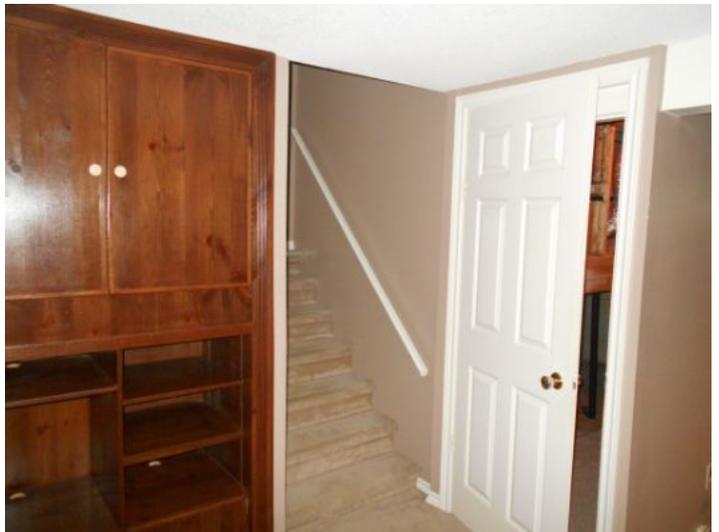
Handrail height less than recommended. Recommend correction for safety.

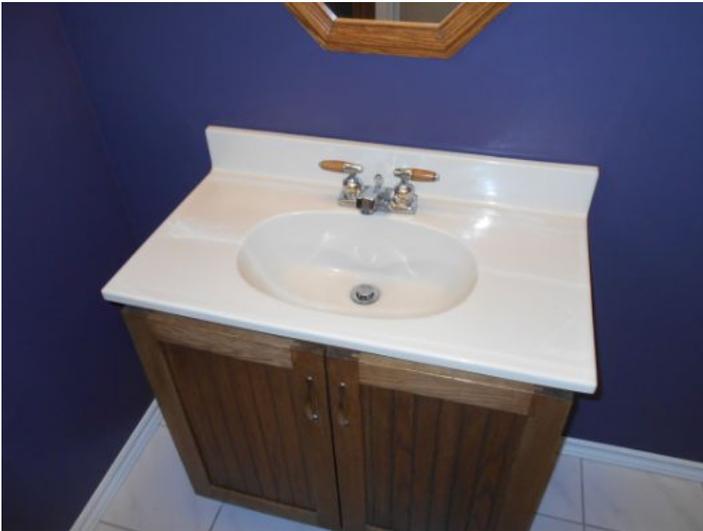
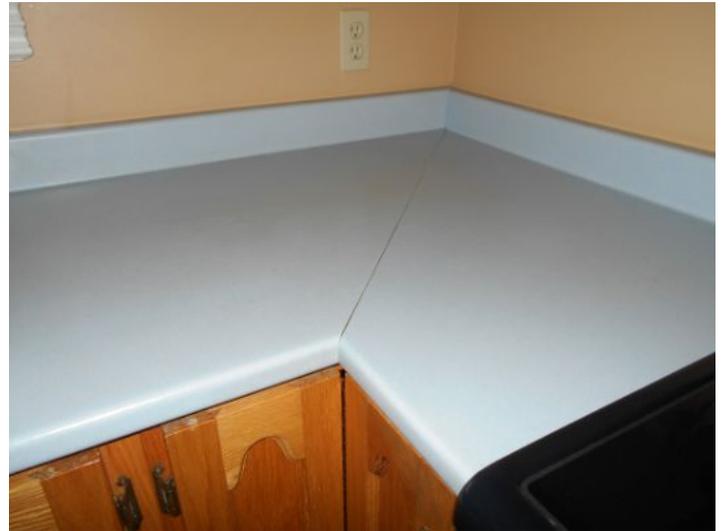
Surface not secured. Counter surface joints not even. Recommend improvement to prevent moisture damage.

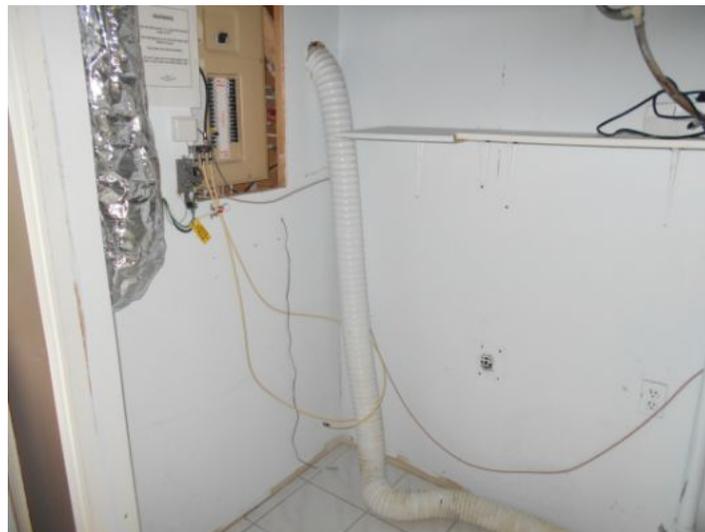
Observations: Plastic duct observed. Ducting should be of metal construction. Recommend replacement due fire hazard.

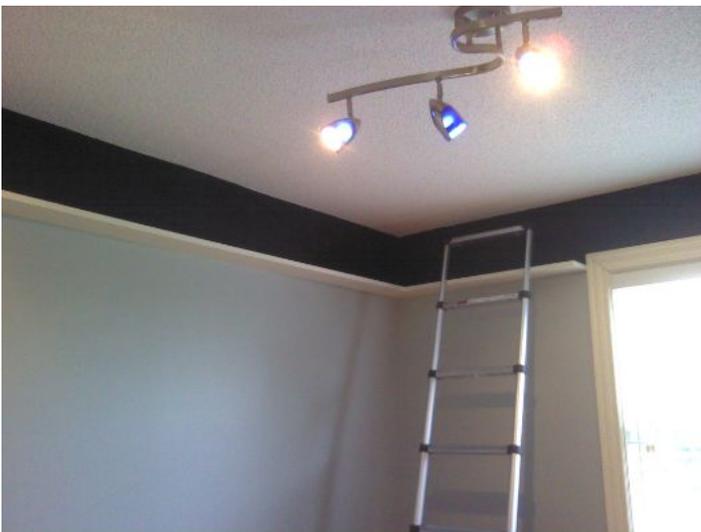
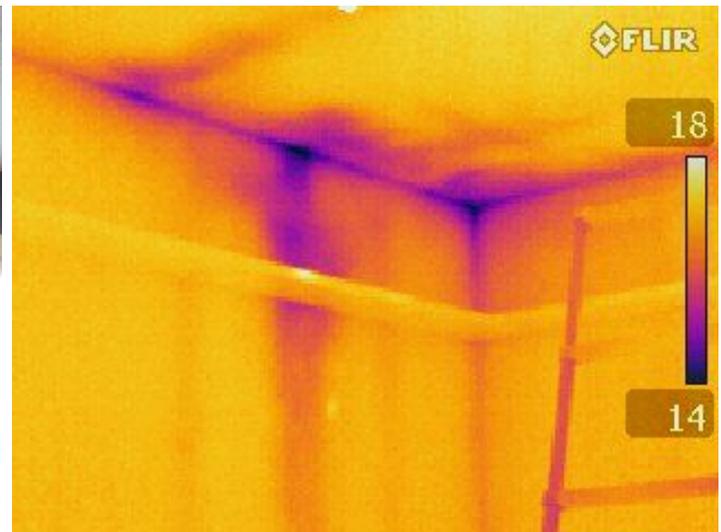
Typical gaps/voids observed. Noted per examples. Recommend improvement where practically accessible for efficiency.
