HOME INSPECTION REPORT

123 Anywhere Drive
St. John's, NL A1C 3Z9

Sample Document

DECEMBER 22, 2023

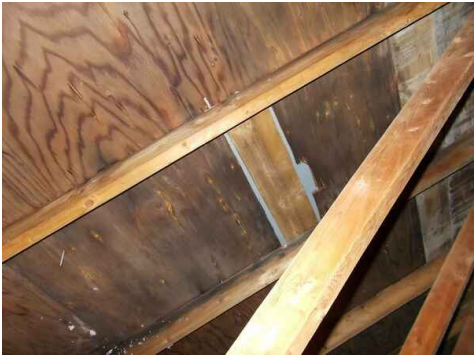
PRIOR REPAIR(S)

Prior repair at sheathing. Recommend monitoring for future condition. Consult a qualified roofer if required.

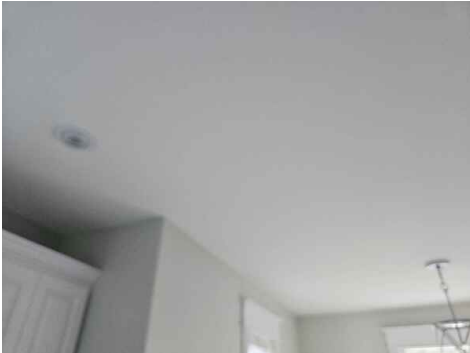
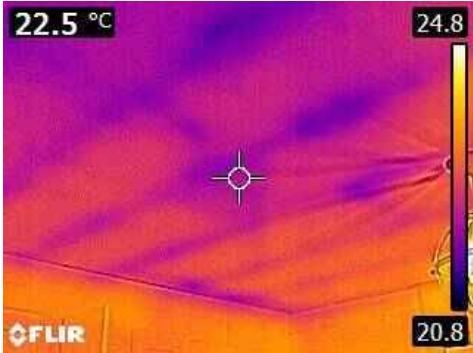
3.1.2 General

MOISTURE OR EVIDENCE OF LEAKAGE

Evidence of moisture identified. Recommend further evaluation by a qualified roofer to prevent water damage.

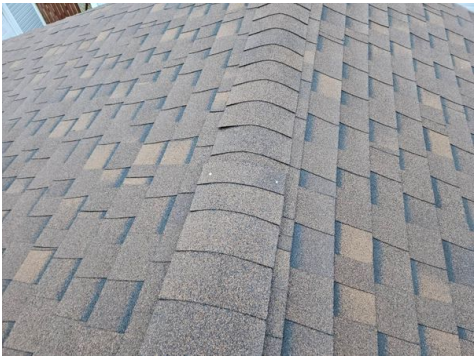
3.3.1 Sloped Roof Covering

EXPOSED NAILS

Recommend correction by a qualified roofer to prevent water damage.

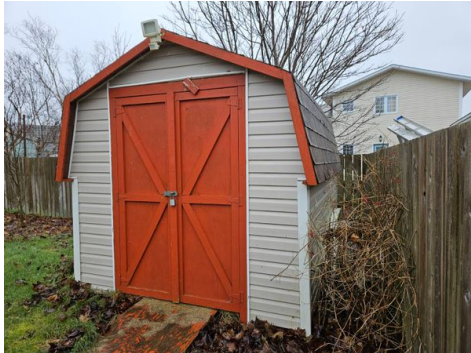
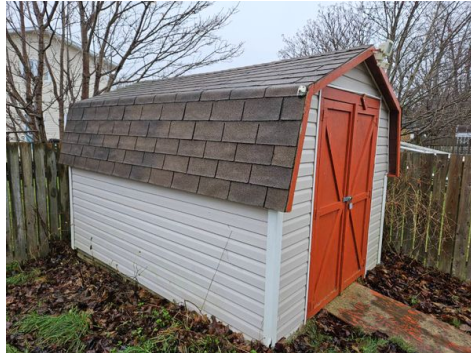
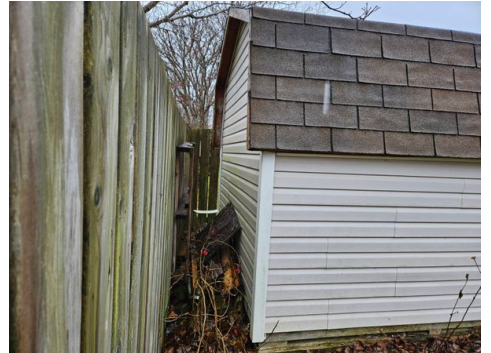
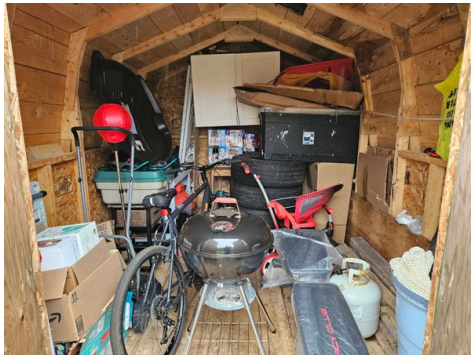
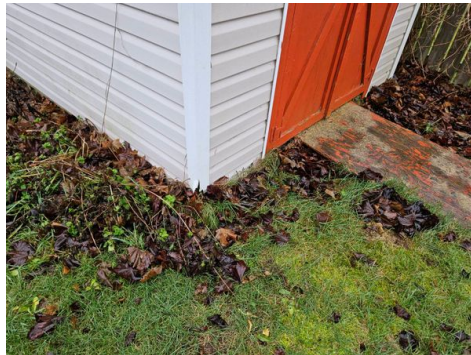
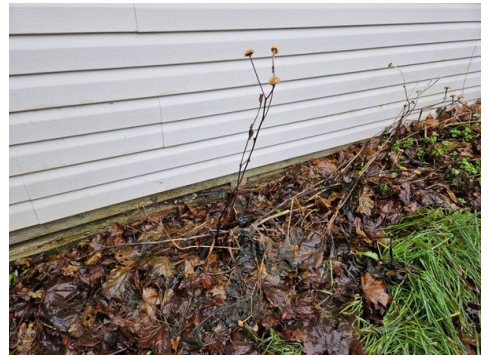
Sheds, outbuildings, landscaping features, fencing, and other detached exterior items or structures were not inspected, and are not commented on as part of the home inspection unless items are specifically agreed upon prior to the inspection and described in the Visual Inspection Agreement as signed by the client. Note: Wood and earth contact and deterioration visible per examples.

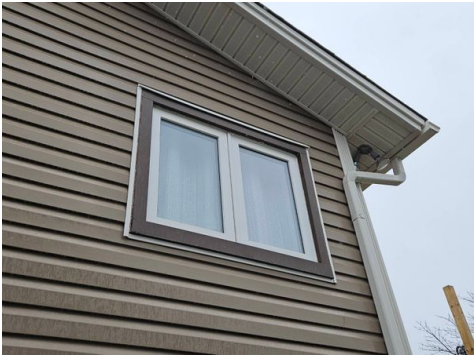
CLAD FRAMING

Window or door opening wood framing not visible where concealed by metal cladding.

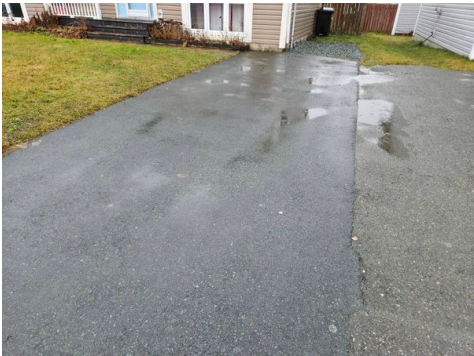
WORN

Surface worn or uneven. Noted due safety. Client may choose to consult qualified personnel for further information.

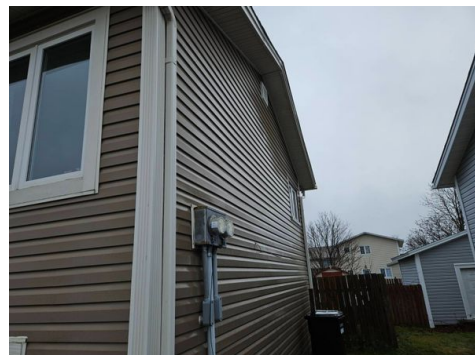
SLIGHTLY WAVY OR BUCKLED

Cladding or wall surface is slightly wavy or buckled. This is a common occurrence. Client may choose to consult qualified personnel for further information.

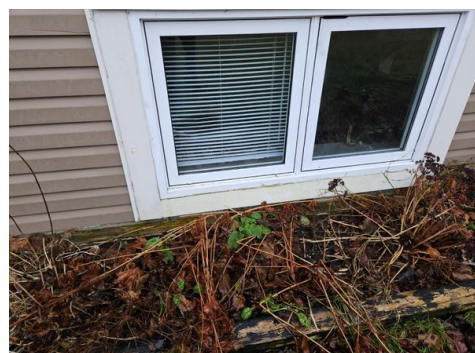
AGED FINISHES

Finishes or caulking worn per example. Recommend correction as required to extend life and prevent deterioration.

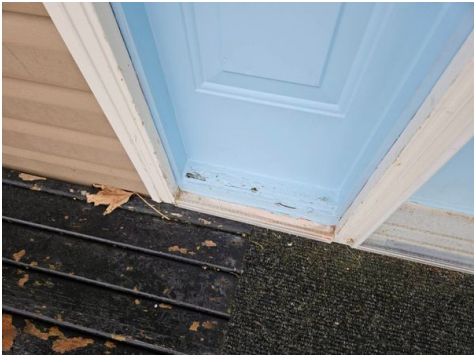
FINISHES

Paint finishes or caulking worn or not present. Deterioration present at the lower side light. Recommend correction as required by qualified personnel to extend life and aid in prevention of moisture entry.

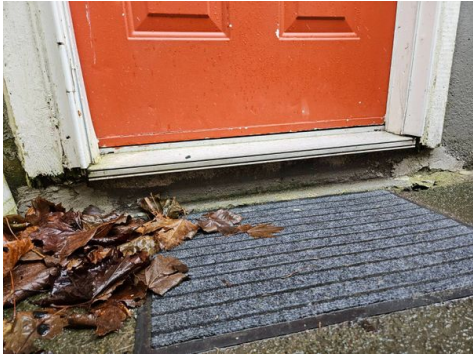
BASEMENT

Surround trim and brick mold deteriorated. Recommend correction as required by qualified personnel to extend life of the door and aid in prevention of moisture entry.

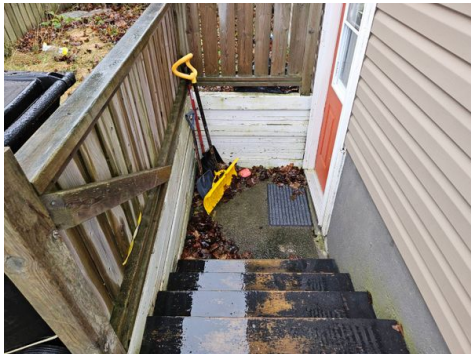
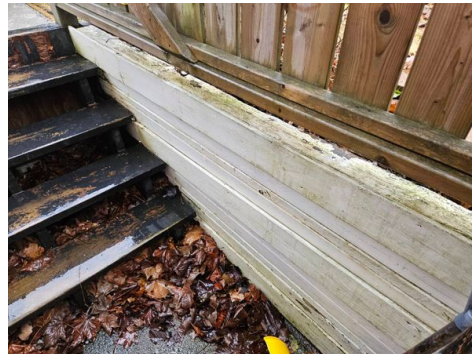
DEFLECTION OR DETERIORATION

Wood stairwell is aged. Evidence of deflection and prior repairs visible. Recommend further evaluation by appropriately qualified personnel.

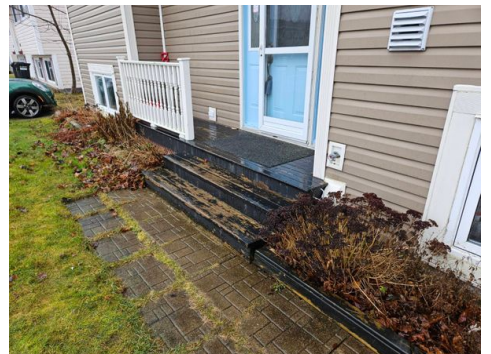
RAILS NOT PRESENT- CONSIDERATION

Consider provision by qualified personnel as a preventative measure.

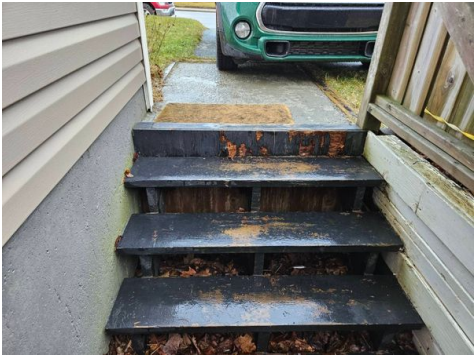
NON TYPICAL DIMENSIONS

Rise non-uniform. Noted for safety. Client may choose to consult qualified personnel for further information.

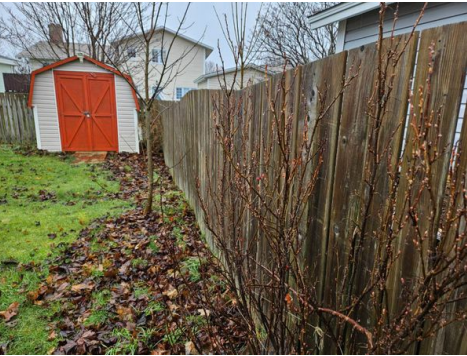
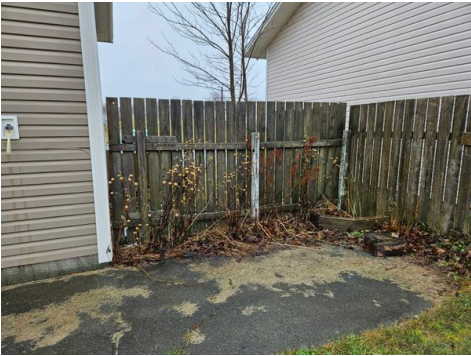
NOT PLUMB

Not plumb. Recommend correction as required by qualified personnel to prevent wind damage.

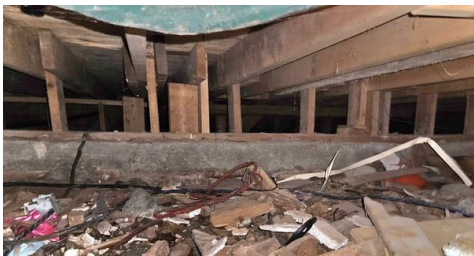
FRAMING METHODS

Framing is not constructed per modern practices. Floors or framing appear not plumb or level at some areas. This is a common occurrence. Bridging, blocking, or strapping is not present between floor joists. Non typical framing or support methods at the subfloor above the crawlspace (a knee wall would typically be provided by modern practice). Noted per example(s). Recommend monitoring for future condition. Client may choose to consult qualified personnel for further information.

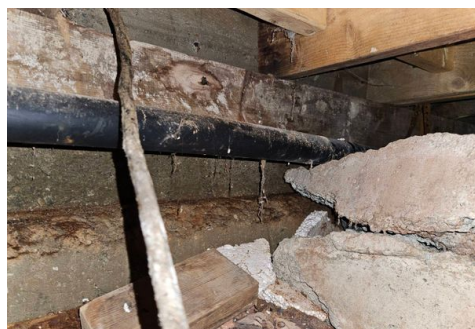
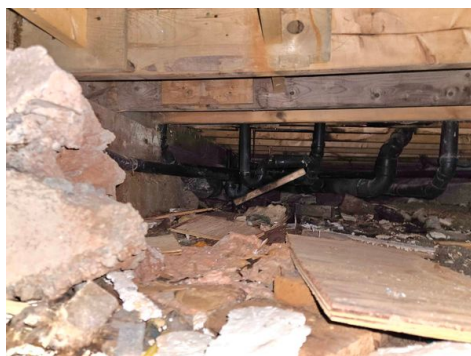
Evidence of elevated humidity at the crawlspace. Prior repairs visible at framing. Ventilation not observed. Recommend further evaluation by appropriately qualified personnel and correction as required to minimize humidity and to prevent future deterioration.

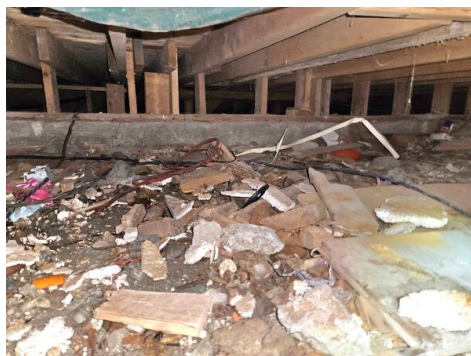
Noted per examples. Recommend removal by qualified personnel to facilitate safe access.

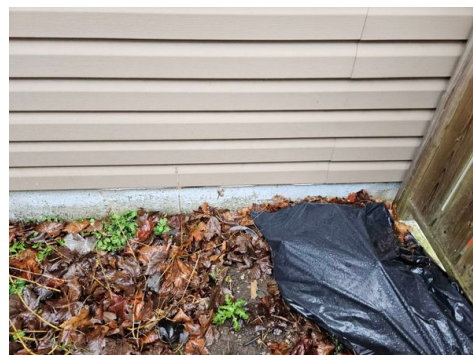
Noted per examples. Recommend monitoring for future condition. Client may choose to consult qualified personnel for further information or evaluation.

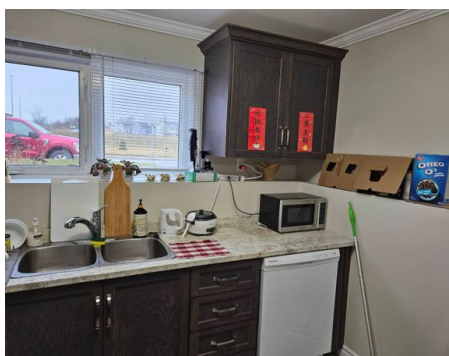
GFCI: Kitchen Near Basin

GFCI protection is not present at kitchen outlets in proximity of the basin. This is a common occurrence based on the age of the home. Recommend provision per modern practice due safety. Note: GFCI protection is present at other applicable locations in the home.

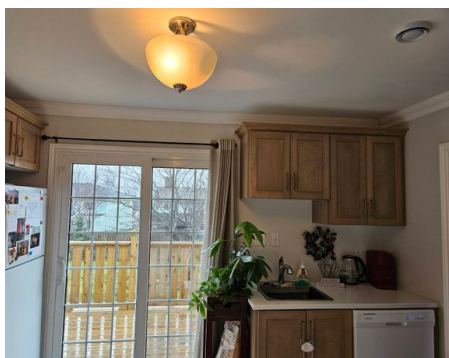
Interior lighting is not controllable from the rear entrance. Noted for informative reasons. Client may choose to consult a licenced electrician for further information.

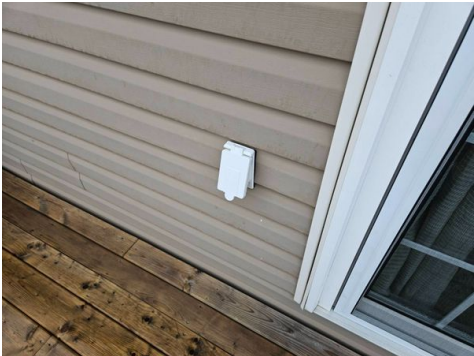
COVER(S) WORN

Recommend replacement.

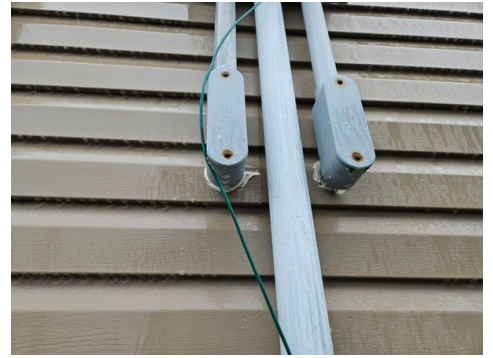
6.5.1 Breaker Panel

AFTERMARKET COVER

An aftermarket cover is provided. Noted for informative reasons. Client may choose to consult a licenced electrician for further information.

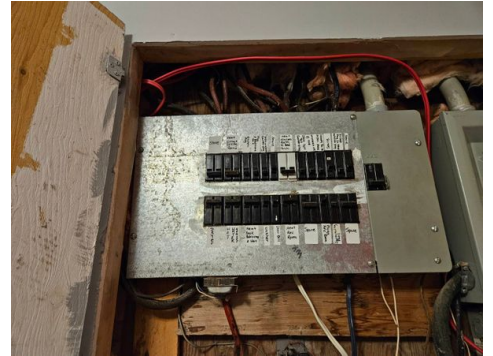
6.5.2 Breaker Panel

RUST OR CORROSION

Rust or corrosion observed. Recommend further evaluation by a licenced electrician due fire safety.

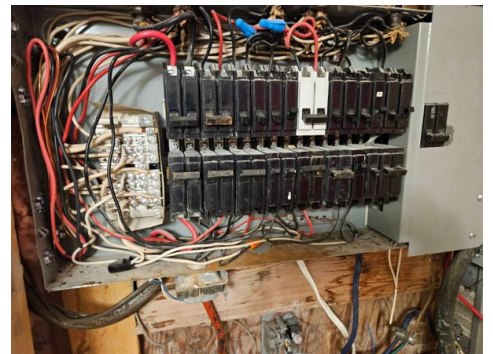
6.5.3 Breaker Panel

ABANDONED WIRING

Unused wiring is not well terminated. Recommend correction by a licenced electrician due fire safety.

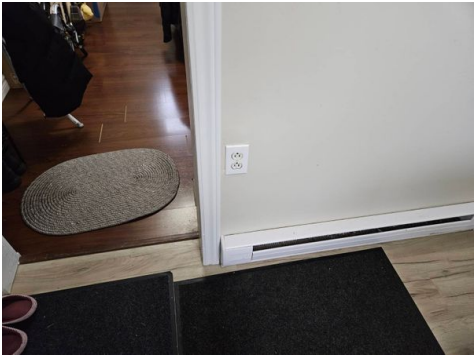
6.8.2 Outlets

RECEPTACLE(S) OBSTRUCTED

MAIN FLOOR HALL

Recommend correction as required by a licenced electrician.

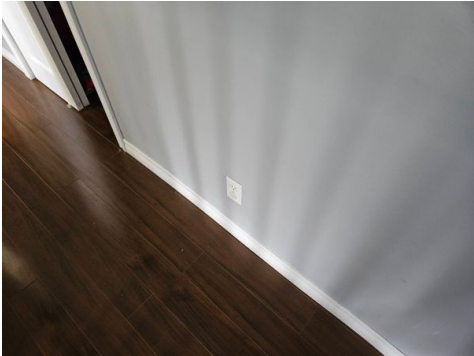
6.11.1 Branch Wiring
BRANCH WIRING

Not well secured. Exposed or improper connections. Covers not present. Insulation damaged. Noted per examples. Recommend further evaluation and correction as required by a licenced electrician due fire safety.

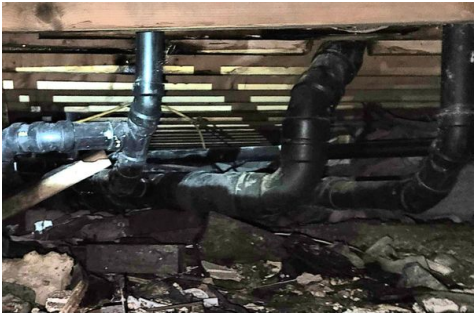
7.1.1 Disclosure

Possibly a shut off for the basement plumbing fixtures. Recommend requesting disclosure from the vendor for informative reasons. Consult qualified personnel if required.

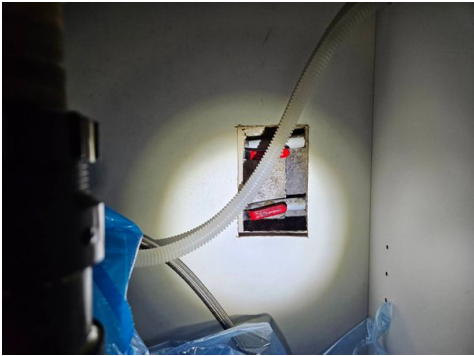
7.2.1 General

EVIDENCE OF PRIOR MOISTURE- MONITOR

No moisture noted at the time of viewing. Recommend monitoring for future evidence. Consult a licenced plumber if required.

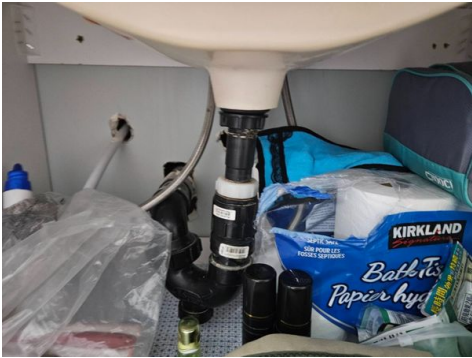
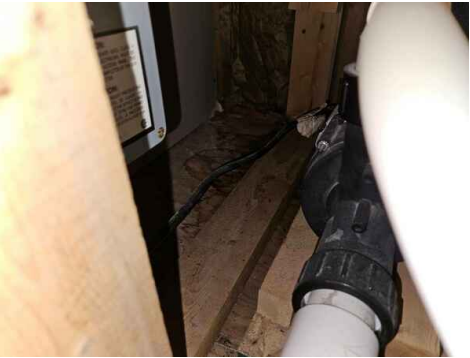
7.3.1 Main Shut Off

NOT VERIFIED

Location of the main water shut off and pressure regulator was not verified. Access to the front of the crawlspace was limited by low height. Readily accessible shut off valves appear to be located at the basement kitchen cabinet. Recommend provision of access to the main entrance equipment by qualified personnel. Consider provision of an access panel through the sub floor.

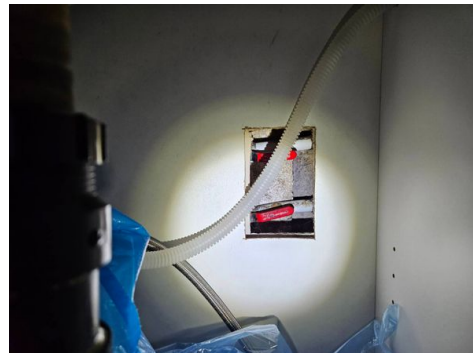
7.6.1 Supply Plumbing

INSULATION NOT PRESENT**CRAWLSPACE**

Insulation is not present at plumbing located at the crawlspace. Recommend provision as required by qualified personnel to prevent freezing.

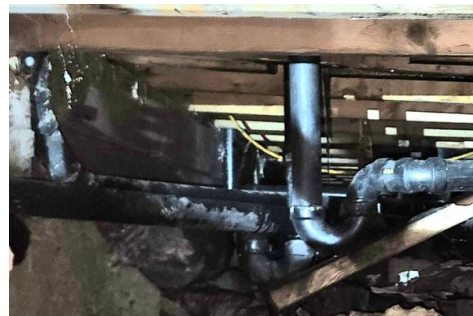
7.7.1 Waste Plumbing

LEAKAGE VISIBLE

Moisture visible at waste plumbing beneath the basement bathroom. Not well supported. Recommend correction as required by a licenced plumber to due sanitary reasons.

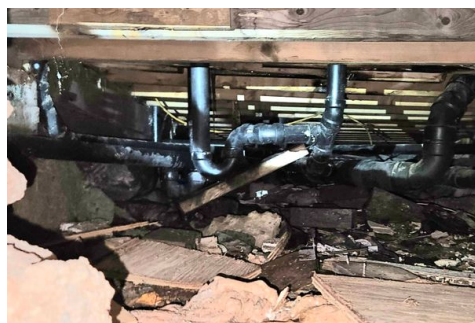
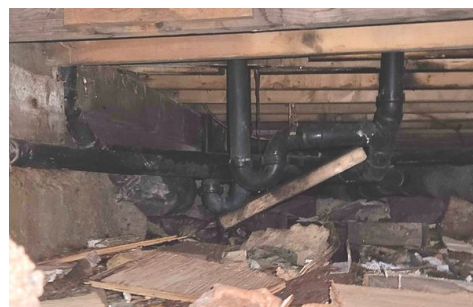
7.7.2 Waste Plumbing

TRAP(S) AT UNHEATED AREA

Waste plumbing trap(s) located at unheated areas may be susceptible to freezing. Client may choose to consult a licenced plumber for further information.

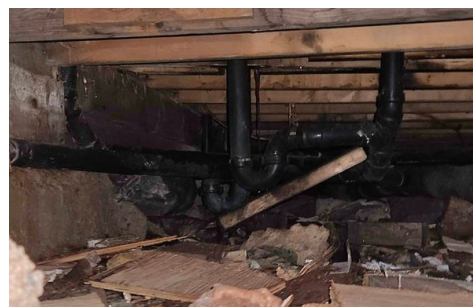
7.9.1 Venting

NOT CONFIGURED TO MODERN STANDARDS

Waste plumbing and venting is not configured to modern standards. This is a common occurrence due to the age of the home. Fixtures appear located further than recommended from venting. Recommend monitoring for proper function. Client may choose to consult a licenced plumber for further information.

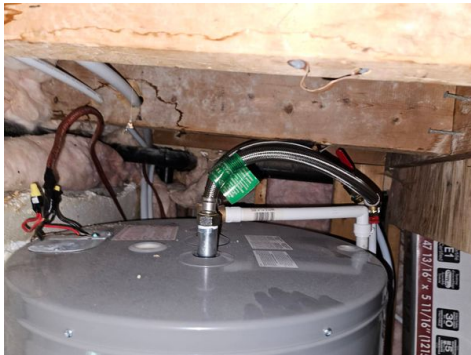
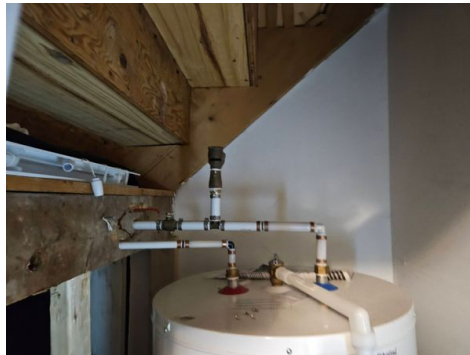
7.12.1 Water Heater Age and Condition

TANK AGE

The data plate is not present. Unable to verify the age of the tank. Recommend requesting disclosure from the vendor. Consult a licenced plumber for further evaluation as required.

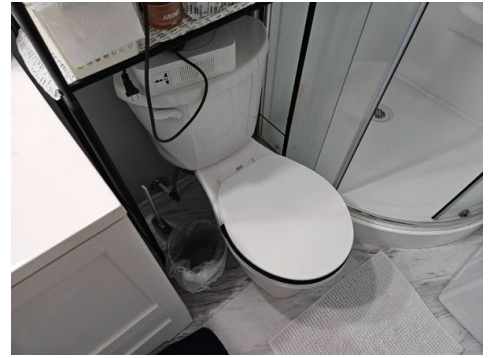
7.15.2 Bathroom

DEFLECTION AT SUB FLOOR

Movement at the toilet base and floor intersection. Deflection observed at sub floor. Recommend correction as required by qualified personnel. Note: Concealed water damage may be present.

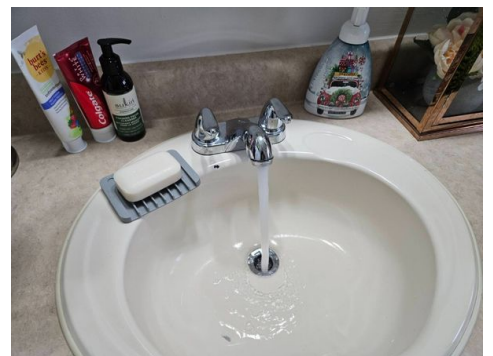
7.15.4 Bathroom

BASEMENT

An overflow drain is not present at the basin(s). There is a susceptibility for overflow if left unattended. Client may choose to consult qualified personnel for further information.

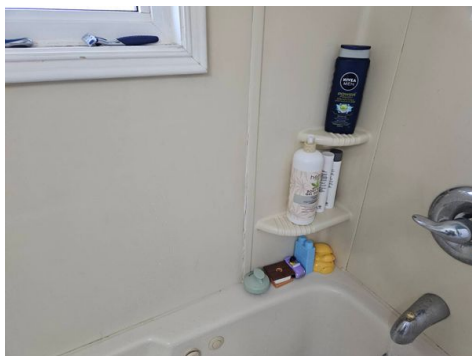
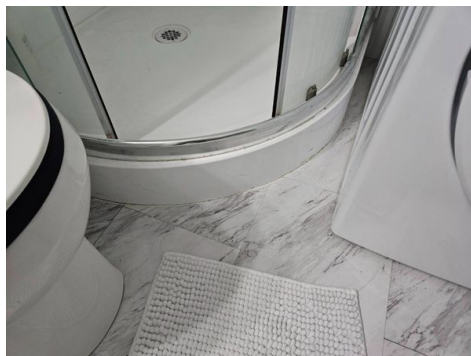
7.17.2 Tub or Shower Enclosures

LEAKAGE AT SHOWER

Glazing or base intersections. Door hardware worn. Recommend correction as required by qualified personnel to prevent water damage.

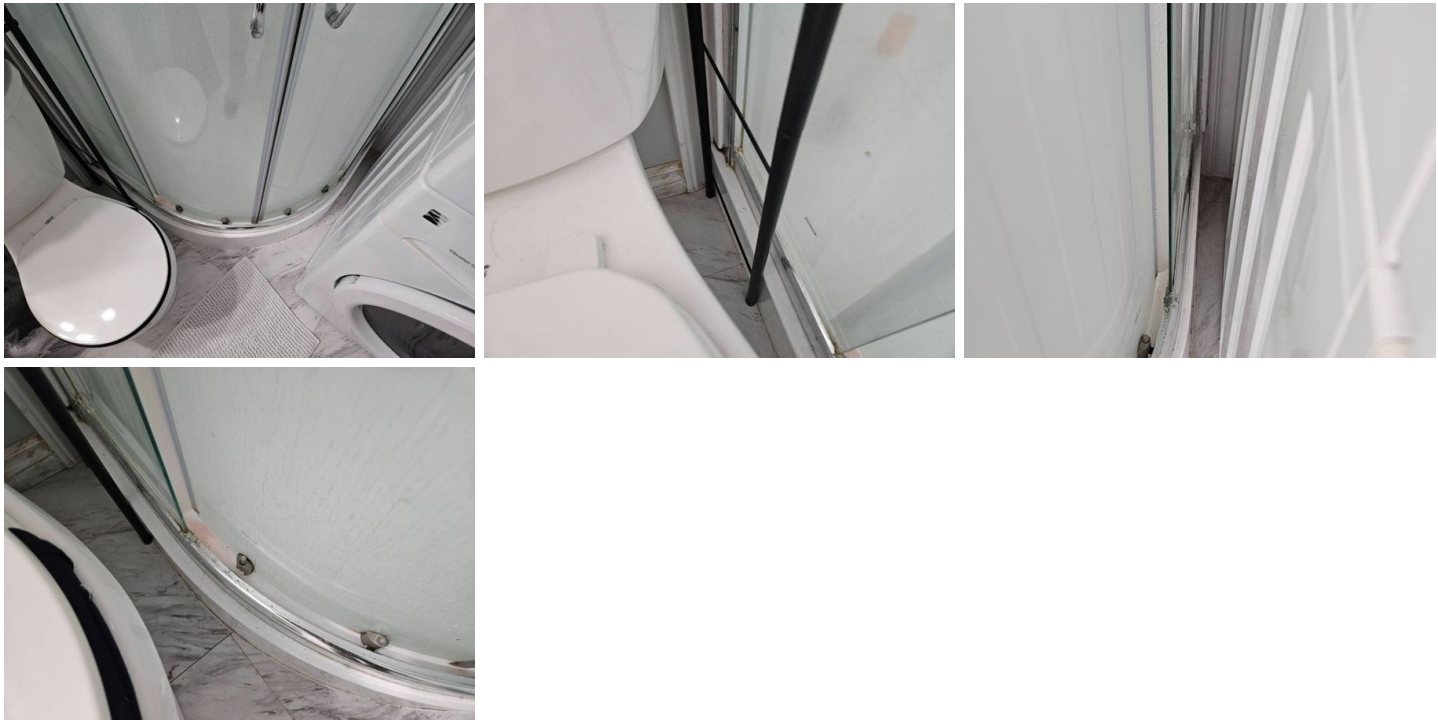
7.17.3 Tub or Shower Enclosures

PRIOR EVIDENCE OF SPILLAGE- TUB

Prior staining visible. Recommend monitoring for future condition. Consult qualified personnel if required.

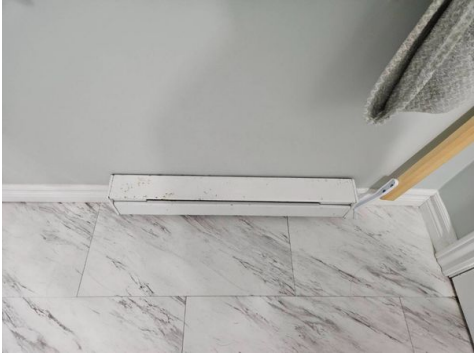
8.6.3 Electric Heating

NOT WELL SECURED

Heater(s) not well secured. Improper wiring connections. Recommend correction as required by a licenced electrician.

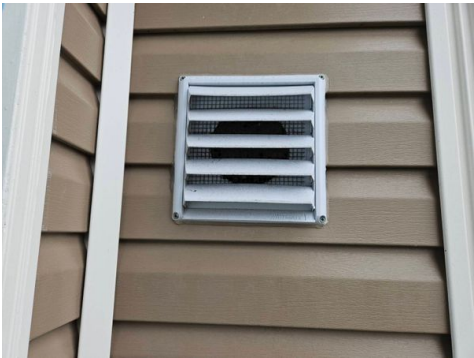
9.2.2 Exterior Vents and Ducting

INLET VENT CLEARANCE

HRV exterior inlet vent distance to exhaust vent(s) less than recommended. Noted for efficiency.

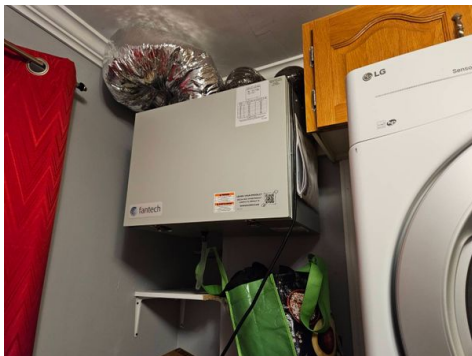
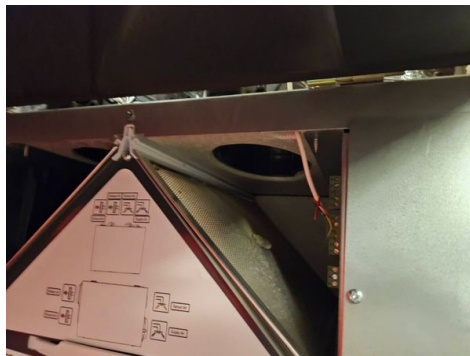
MAIN FLOOR

CLEANING RECOMMENDED

Unit and Filters require cleaning (common). Recommend servicing by a qualified HVAC technician.

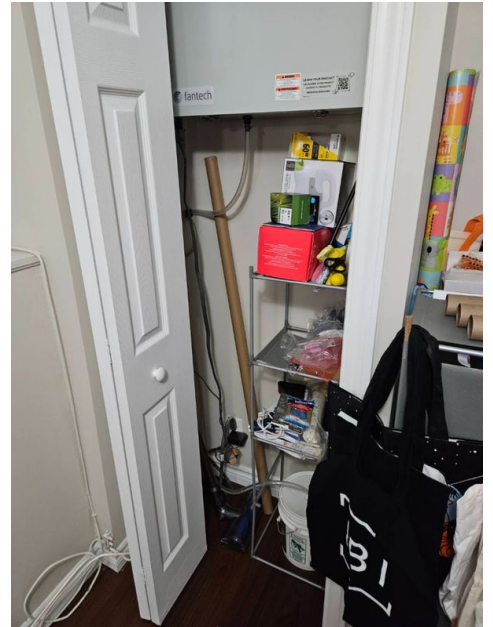
BASEMENT

Condensate drain line discharges into a container (common). Consider discharging through an opening in the subfloor to the crawlspace per modern practice to aid in prevention of spillage.

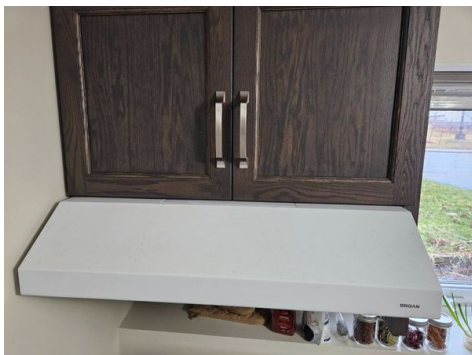
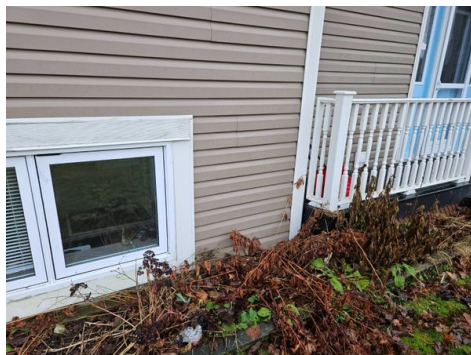
BASEMENT

A grille not present at the range hood to allow re-circulation of air (airflow is restricted). This model of range hood appears intended to be vented to the exterior through a duct and weather hood only. Recommend correction as required by qualified personnel.

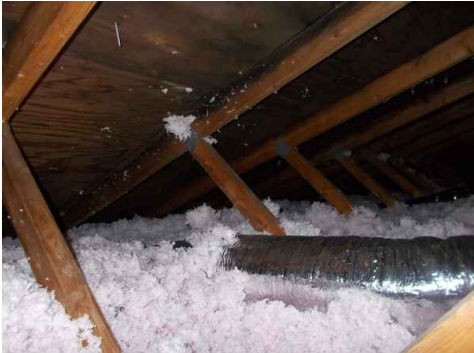
Darkening or discolouration observed. This is a common observation based on the age of home. Client may choose to have further evaluation completed by qualified personnel. Refer to attic ventilation comments.

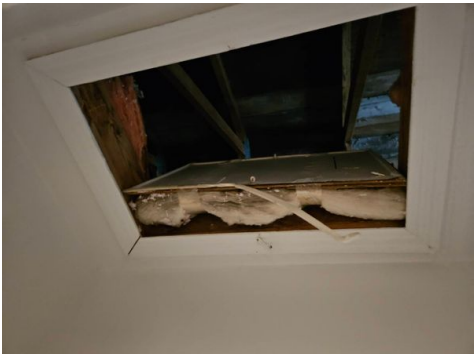
10.2.1 Attic Insulation

HATCH PLUG NOT INSULATED

The access hatch plug is not well insulated and weather stripped. Recommend improvement for efficiency.

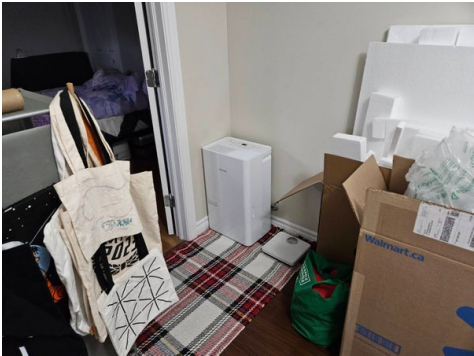
11.2.1 Environmental

DEHUMIDIFIER OBSERVED

This is a common observation. Recommend requesting disclosure from the vendor to any prior moisture related issues. Consult qualified personnel for further evaluation as required.

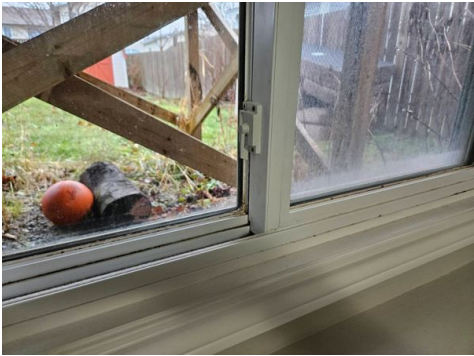
11.2.2 Environmental

DISCOLOURATION- HRV

Evidence of humidity or discolouration observed at windows or not well heated areas. Recommend cleaning and ensure that the HRV's are operated on the correct setting. Recommend monitoring for future evidence. Consult qualified personnel if required. Note: Both HRV's were turned off, or not in use by the occupants at the time of viewing.

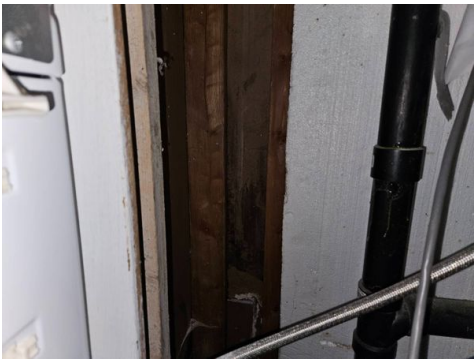
11.3.1 General

WATER DAMAGE

Prior water damage or discolouration observed at finishes. Recommend further evaluation and correction as required by qualified personnel. Concealed water damage may be present.

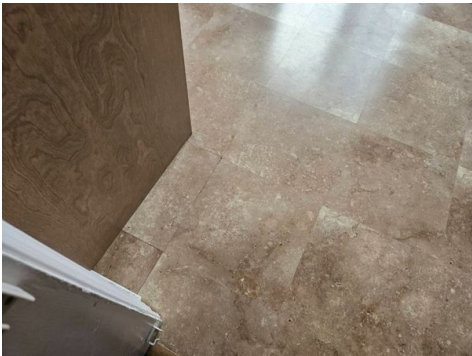
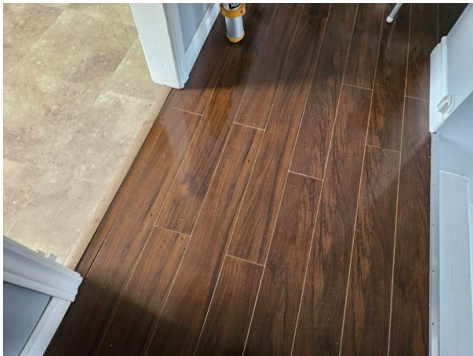
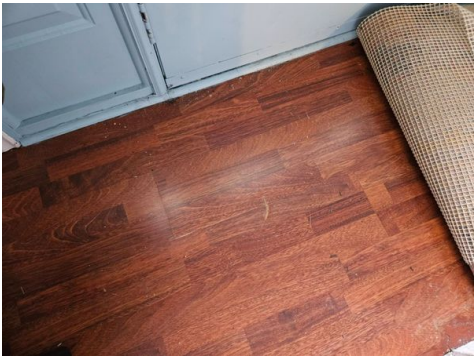
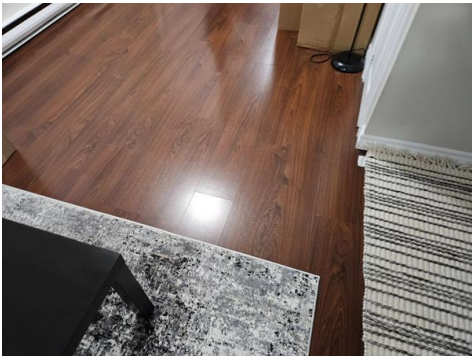
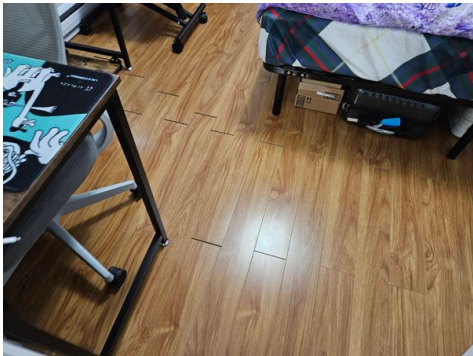
11.6.1 Floors

FLOORING CONDITIONS

These may include items such as wear, gaps, moisture damage, buckling, wrinkles, etc. Noted per example(s) for informative reasons.

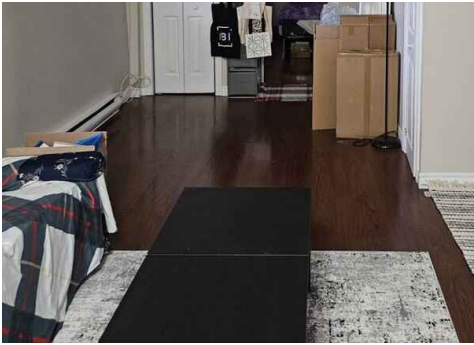
11.6.2 Floors

DEFLECTION-COMMON

Deflection observed at some areas of stairs, flooring, or sub floor (common). Noted for informative reasons. Client may choose to consult qualified personnel for further information.

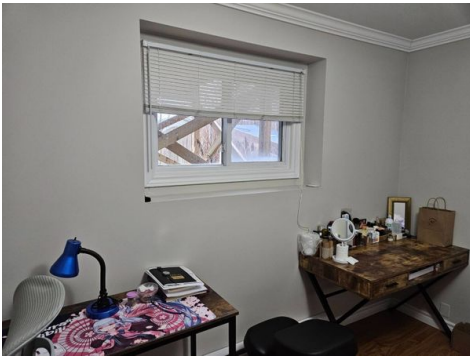
11.7.1 Windows

DIMENSIONS AT BEDROOM

BASEMENT, MAIN FLOOR REAR

Bedroom window opening dimensions are less than the modern egress requirements. Noted for safety. Client may choose to consult qualified personnel for further information.

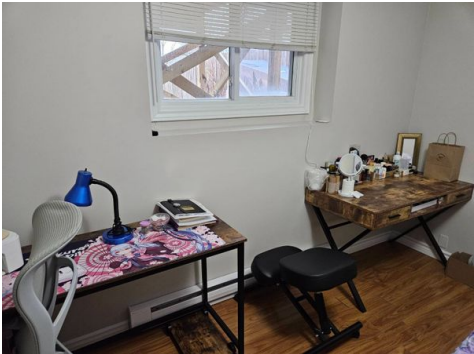
11.7.2 Windows

WINDOW HEIGHT

Height of basement window(s) from the floor greater than recommended by modern practice without suitable means of access such as furniture, if utilized as a bedroom. Noted per examples due safety. Client may choose to consult qualified personnel for further information.

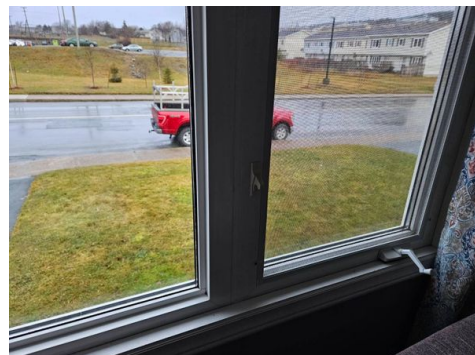
11.7.3 Windows

LATCH EXTENSIONS

Worn. Recommend correction by qualified personnel.

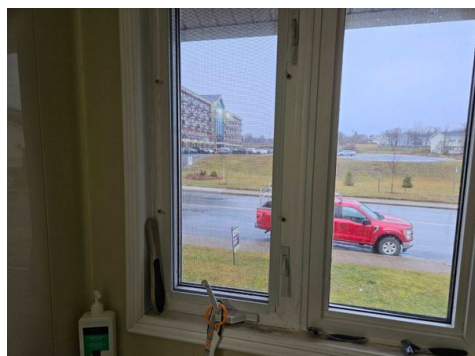
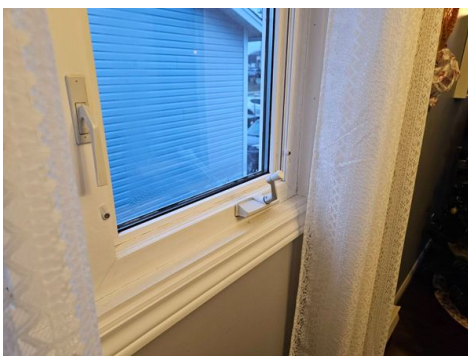
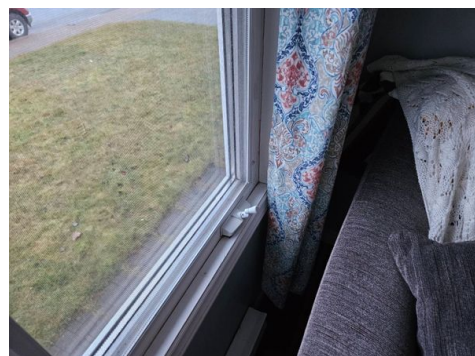
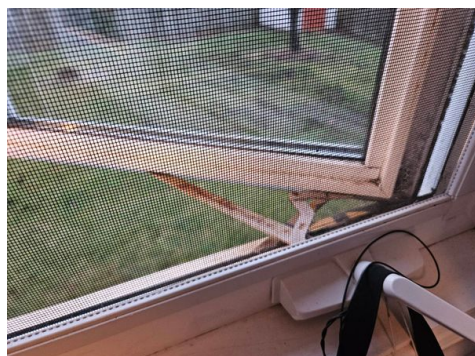
11.7.4 Windows

HARDWARE WORN

Main bathroom, dining room, living room, rear bedroom. Hardware is worn or inoperable. Recommend correction as required by qualified personnel.

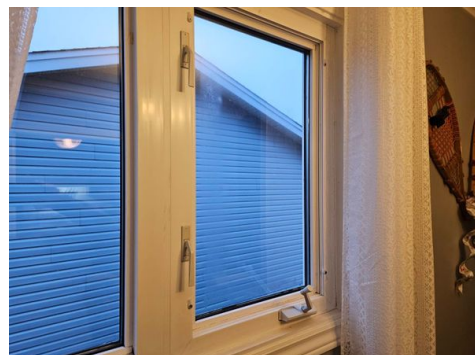
11.7.5 Windows

FAILED INSERT SEAL

Condensation observed between panes due failed insert seal at window(s) (common). This is primarily a cosmetic condition. Client may choose to consult qualified personnel for further information or repair.

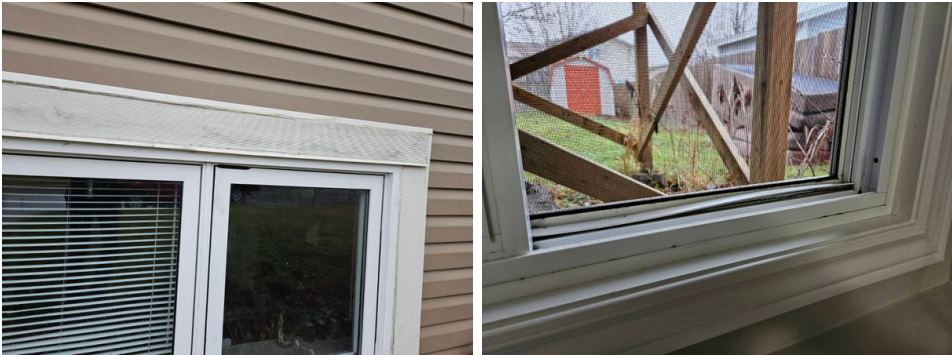
11.7.6 Windows

WEATHER STRIPPING

Worn. Recommend correction due efficiency.

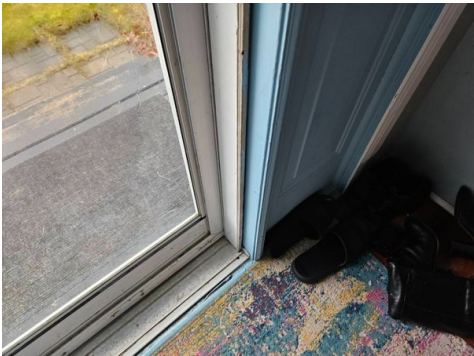
11.8.1 Exterior Doors

WEATHER STRIPPING

Weather stripping aged or worn. Recommend correction as required for efficiency and to aid in prevention of moisture entry.

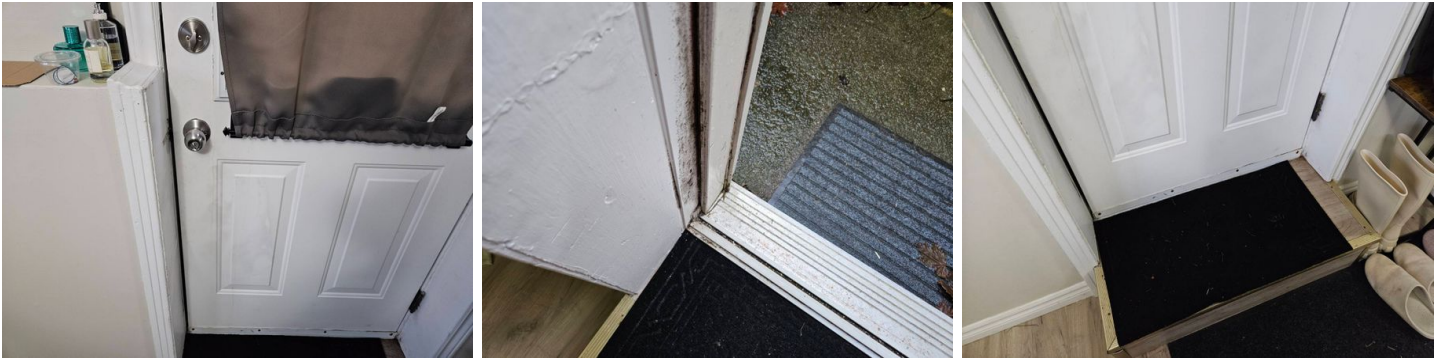
11.8.2 Exterior Doors

EVIDENCE OF PRIOR MOISTURE

Staining or evidence of prior moisture observed. Weather stripping appears aged or ineffective. Recommend correction as required by qualified personnel.

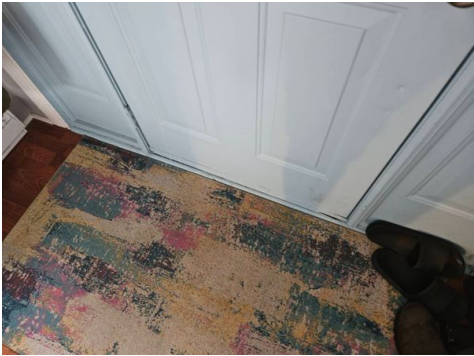
11.8.3 Exterior Doors

SWEEP CONTACTS SILL

FRONT

Recommend adjustment or improvement as required.

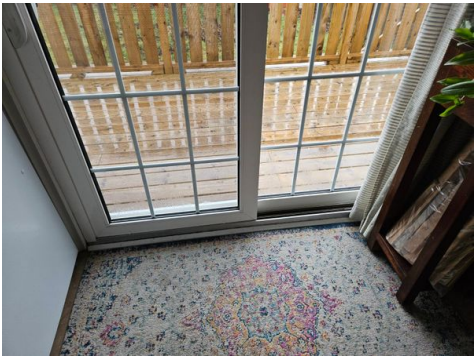
FAILED INSERT SEAL

REAR

Condensation observed between panes due failed insert seal at window(s) (common). This is primarily cosmetic. Noted for informative reasons. Client may choose to consult qualified personnel for further information or repair.

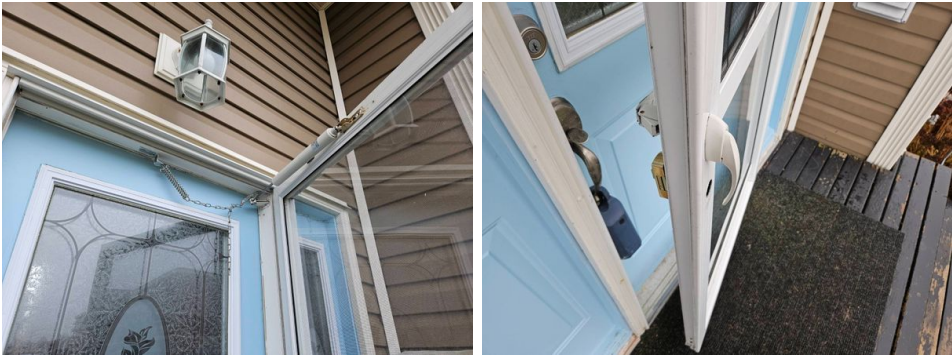
11.8.6 Exterior Doors

STORM DOOR HARDWARE

Worn or incomplete. Recommend correction by qualified personnel.

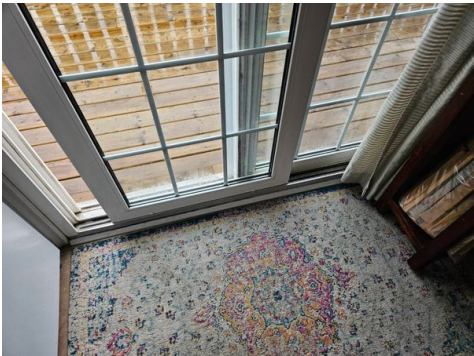
11.8.7 Exterior Doors

SLIDING DOOR OPERATION

Slight resistance during operation. Recommend adjustment or correction as required by qualified personnel.

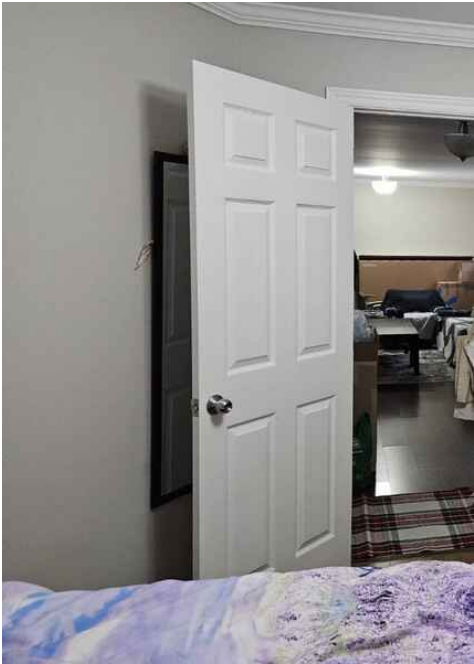
Door stops are not present at some locations. Recommend provision to prevent damage to wall finishes.

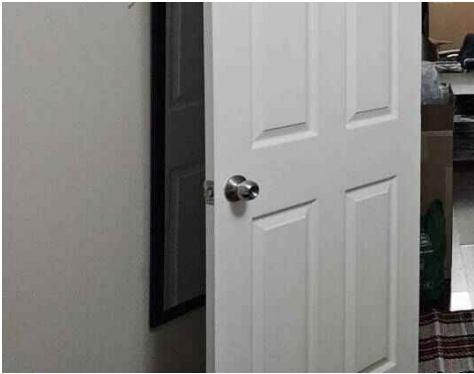
11.9.2 Interior Doors

BEDROOM DOOR KNOB(S)

Bedroom door knobs are not privacy (locking) type, or a latch is not present at some locations (personal preference). Noted for privacy.

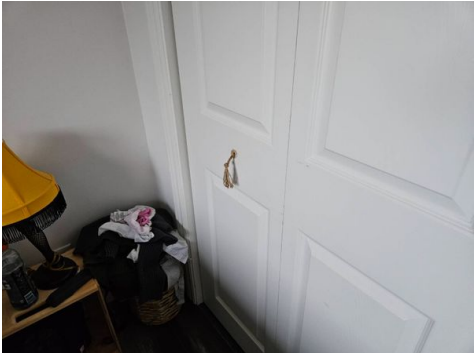
11.9.3 Interior Doors

HARDWARE

Hardware worn or not present. Recommend correction as required.

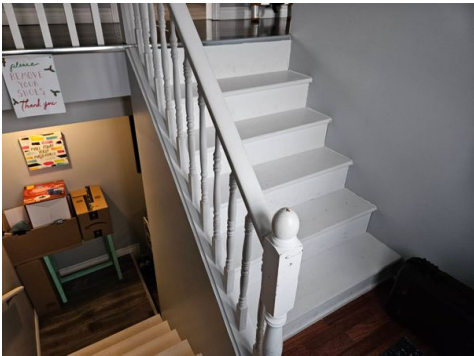
11.11.1 Hand and Guard Rails

MOVEMENT NOTED

Movement at the rail. Recommend correction by qualified personnel due safety.

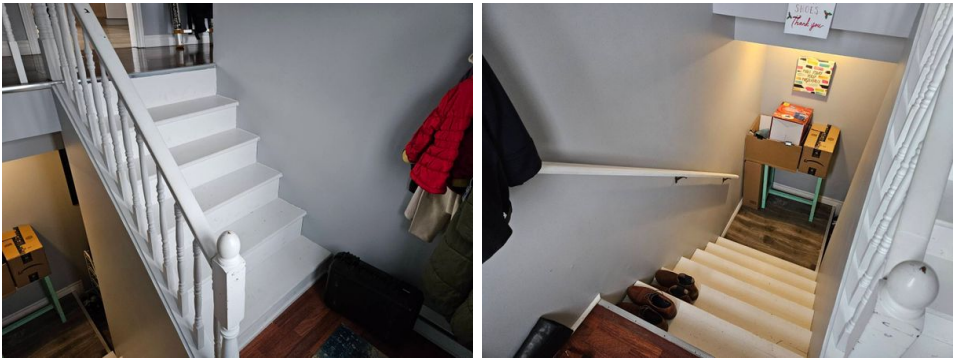
11.12.1 Stairs

NOT CONSTRUCTED TO MODERN STANDARDS

Headroom is less than recommended. Rise is non uniform, or non typical dimensions. Not level, etc. Noted for safety. Client may choose to consult qualified personnel for further information.

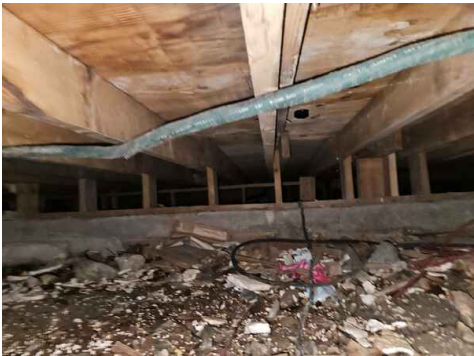
11.14.1 Crawlspace Moisture

CRAWLSPACE GENERAL

Earth floor crawl spaces may be susceptible to moisture entry under some circumstances due to construction and drainage methods. Recommend requesting disclosure from the vendor to the presence of any prior moisture related occurrences. Client may choose to consult qualified personnel for further information or evaluation.

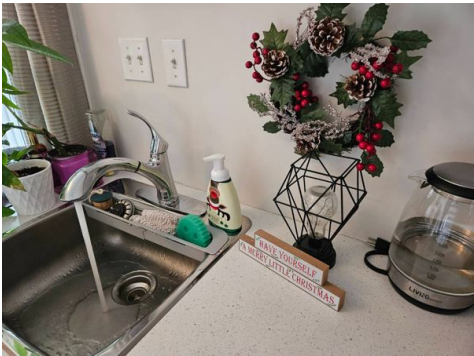
11.15.1 Cabinets

SURFACE JOINTS- CONSIDERATION

Surface joint(s) are not caulked. Consider caulking to aid in prevention of possible water damage. Note: This is often not completed due to personal preference for cosmetic reasons.

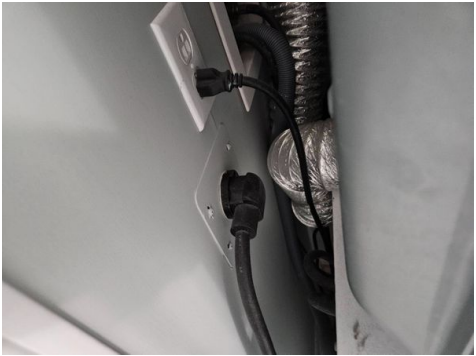
11.16.1 Dryer Duct

DUCT NOT WELL ROUTED

Dryer duct. Recommend correction by qualified personnel due fire safety.

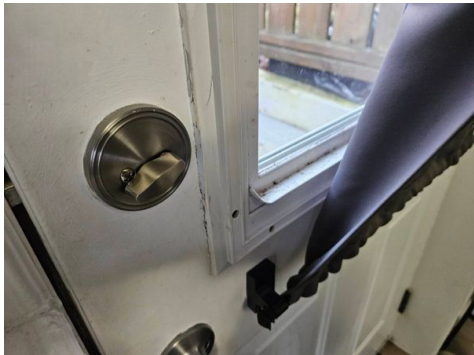
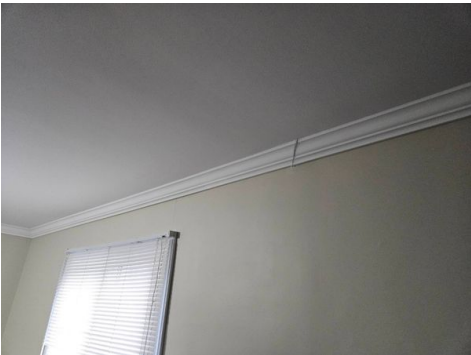
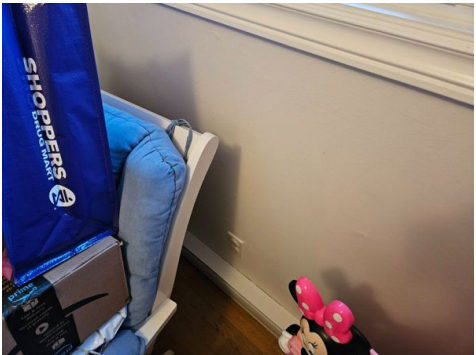
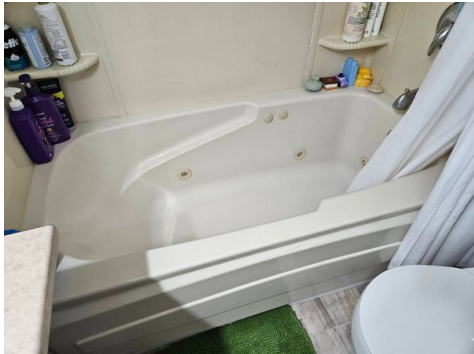
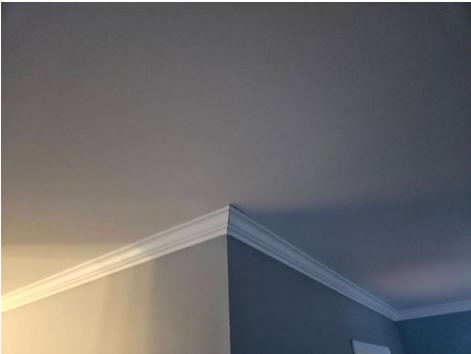
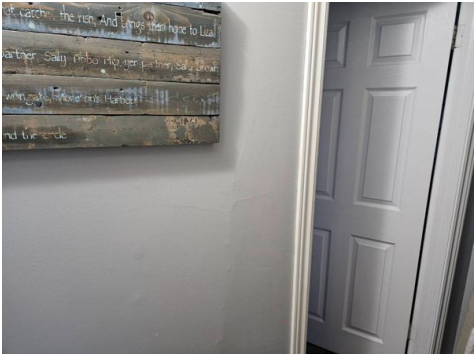
11.17.1 Additional Comments

MINOR OR COSMETIC ITEMS

Cracking at drywall or plaster joints, nail pops, minor wear, finishes incomplete, etc. were observed at some locations. These appear to be cosmetic in nature. Noted per examples for client courtesy.

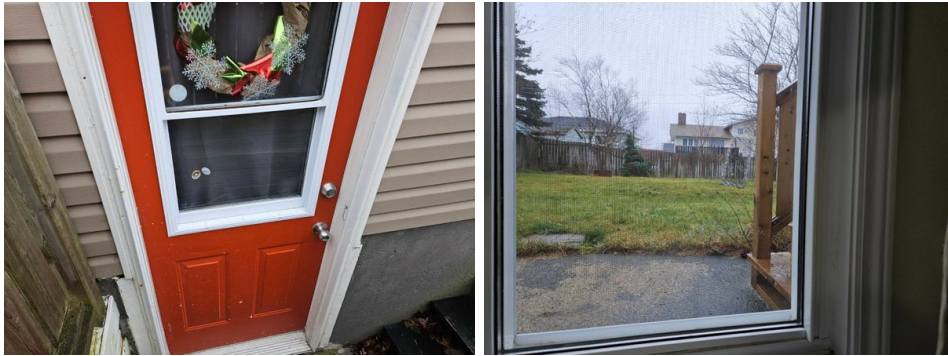
11.17.2 Additional Comments

SCREEN(S) NOT PRESENT OR WORN

Noted per examples for client courtesy. Recommend provision as applicable.

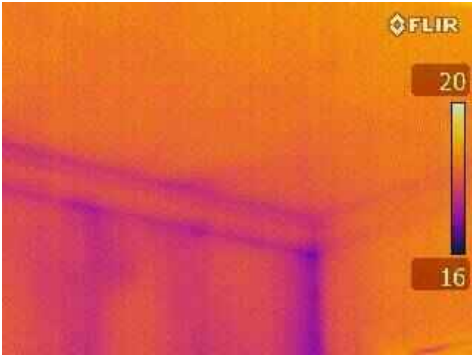
General photos. Typical gaps or voids observed at some locations. This is a common occurrence due to the age of the home. Images provided for informative reasons.
